# Building Inspection Report

**Long Beach, CA**

**Prepared By:**  
Beachside Property Inspection, LLC  
5318 E. 2<sup>nd</sup> St., #707  
Long Beach, CA, 90803  
ph. (562) 433-2288

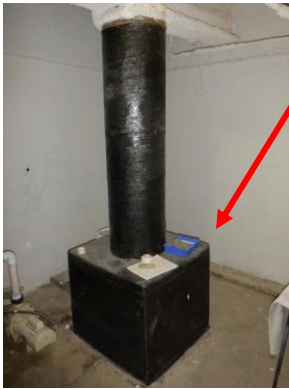
1. **Monitor:** The garage shows repairs at two concrete columns (one within the pool equipment area and the other just outside the pool equipment area). The garage column suffered an auto impact (disclosed by seller representatives) where epoxy filler and wrap were used for repairs while the pool equipment area column exhibited swelling of the embedded steel rebar that displaced the concrete base where a formed concrete cast was installed around the damaged areas; suggest a review of the installation guidelines/documentation and improving as needed by a licensed contractor.

A support column at the pool equipment area required re-supporting the base due to excessive corrosion of the embedded steel reinforcing bars

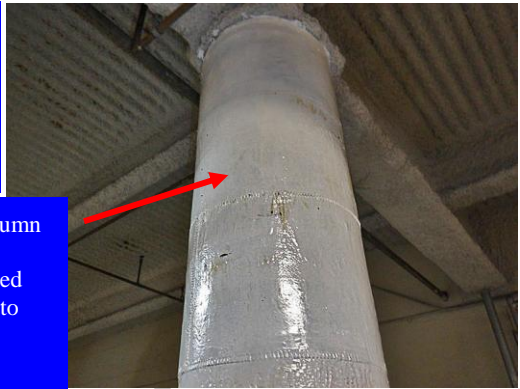
The garage support column adjacent to the pool equipment room required repairs following an auto impact

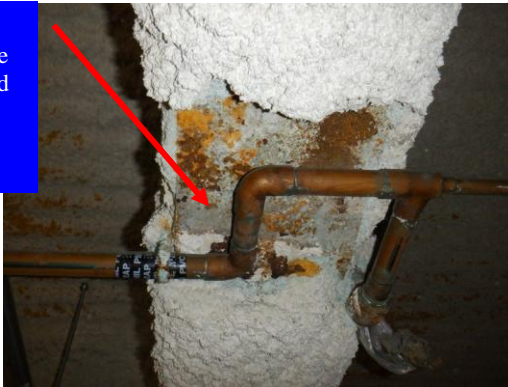
2. **Monitor:** The garage ceiling shows a number of discolored fire retardant material mostly at pipe penetrations that appear related to past leaks at the common area patio above; suggest further inquiry with the seller.

Some of fire retardant at the garage ceiling structure has been removed here and there

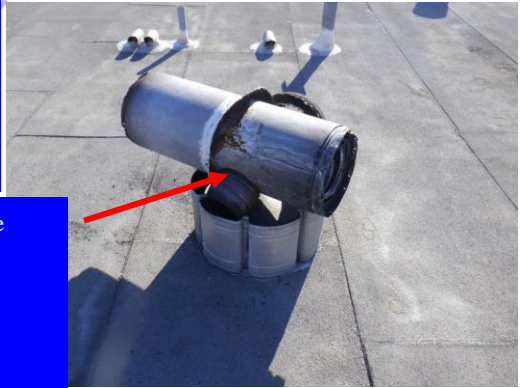
2. **Major Improve/Safety Issue:** The rooftop has a number of fireplace metal chimney pipes (12) of which 3 are no longer in use (3<sup>rd</sup> level dwelling unit numbers are used to identify their approximate locations) of which the 302 pipe is a disassembled pile set atop the roof opening it once passed through, the 308 pipe remains loosely set within the roof opening where it rests atop the ceiling finish and the 310 chimney has its cap replaced with a flat sheet metal sealing the top of the pipe. Additionally, of the remaining 9 chimneys, the ones at 307, 311 & 312 are fitted with gas appliance vent caps that are not listed for wood burning fireplace chimney caps (improper caps restrict the discharge of combustion products within the living space). The balance of chimney caps appear correct, however, the cap at 306A is collapsing; suggest immediate assessment and repairs by a licensed chimney contractor.

302: Three of fireplace chimneys have been abandoned where the assembly has been stacked...

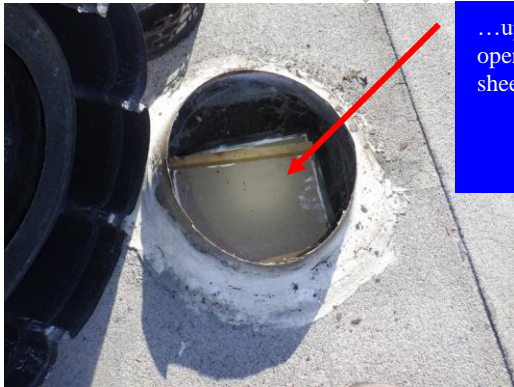
...upon the uncapped-roof opening (here, ceiling sheetrock is visible)...

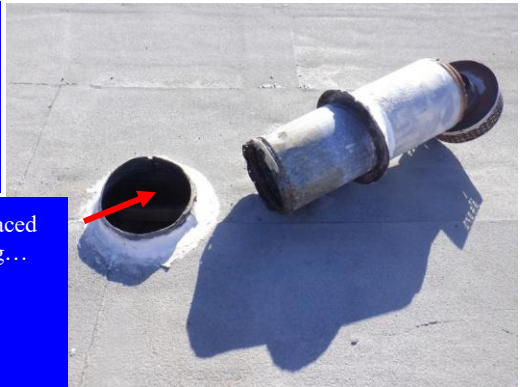
308...or are loosely placed within the roof opening...

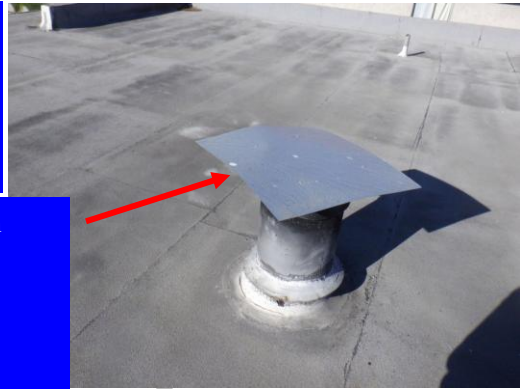
310...others have been capped-off

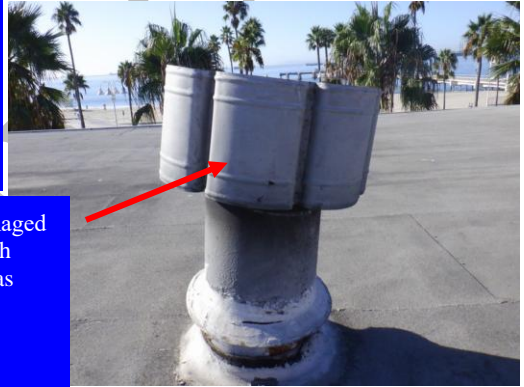
306A: The proper chimney cap is collapsing...

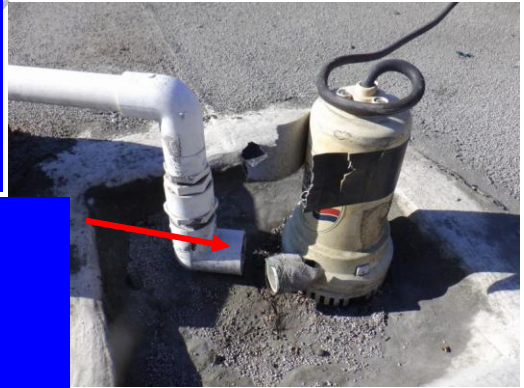
The roof has added drain area pumps where two did not respond, some have deteriorated roofing materials where water can enter...

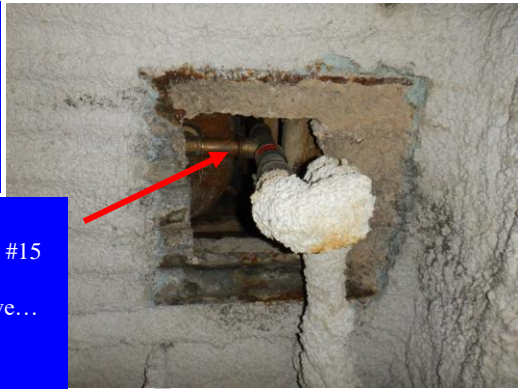
1. **Safety Issue:** Proper fire separation between the garage and living space above is required where 1<sup>st</sup> floor tub plumbing-access hatches at the garage ceiling are either missing such as adjacent to marked parking stall #15 or have a poorly fitted access hatch as noted adjacent to marked parking stall #4 that must be corrected to prevent the spread of fire within the living space. Further, the laundry area water heater located at the far NW-closet includes a wall opening to the garage that is common to that stairway’s wood framing that requires the framing be clad with the proper sheetrock.

The garage has ceiling openings such as at the #15 column where fire can enter the structure above...

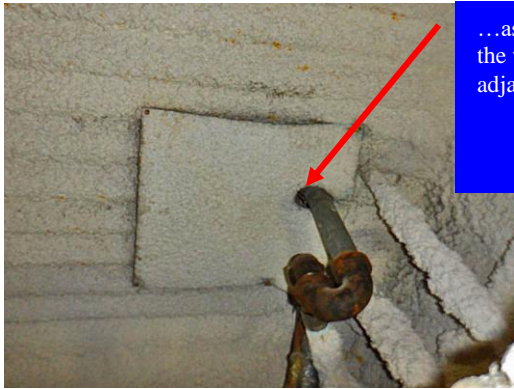
...as well as gaps such as at the waste pipe access adjacent to column #4

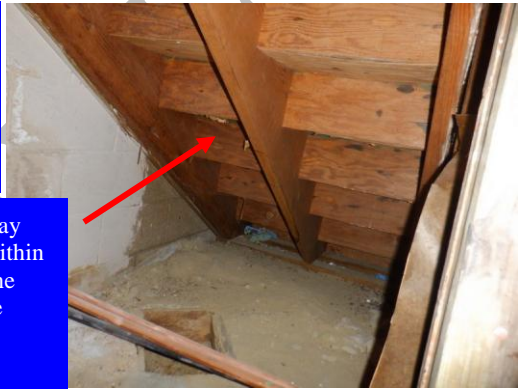
The garage NW-stairway has exposed framing within a closet that opens to the garage that requires the framing be clad with sheetrock

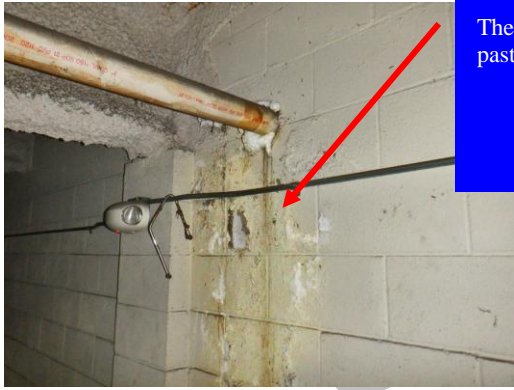
The garage W-wall shows past water infiltration

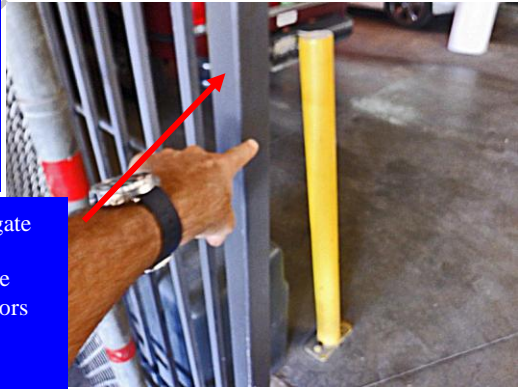
2. **Safety Issue:** The #307 deck railing is easily rocked and shows extensive corrosion at the mounting posts where immediate repairs are needed.
3. **Safety Issue:** The automatic garage gate lacks at least two automatic reversing mechanisms to prevent entrapment. *There is a serious risk of injury, particularly to children, under this condition that* should be dealt with immediately. These provisions are similar to those for automatic overhead garage doors which include a sensing device that will reverse the gate if it encounters an obstruction when operating, a secondary sensing mechanism such as an electric eye or an edge sensor that will reverse the gate if an obstruction is detected. Further, elimination of all gaps over 2.25 inches, installation of controls far enough from the gate so users cannot come into contact with the gate while operating the controls, installation of controls where the user has full view of the gate operation, elimination of pinch points, installation of guarding on exposed rollers and posting of warning signs on each side of the gate; suggest improving as needed by a licensed specialist.

The garage automatic gate lacks auto-reversing features such as an edge sensor and optical sensors

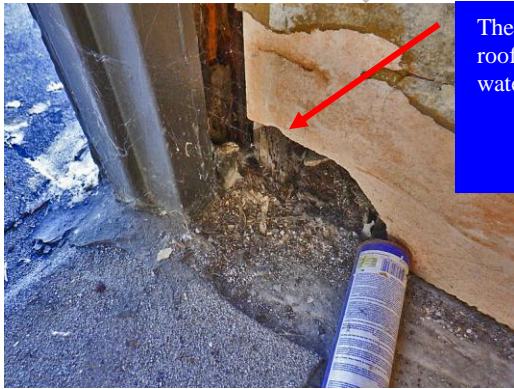
10. **Improve:** The rooftop storage room at the NE-corner is prone to water entry at the base of the doorway where damage was observed at the abutting interior finishes; suggest improving as needed.

The rooftop NE-storage roof entry way is prone to water entry

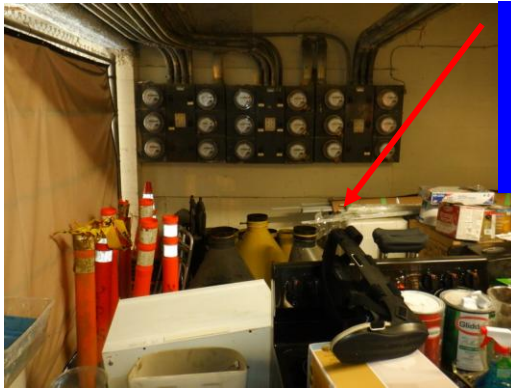
The SE-electrical service area lacks service clearance due to storage...

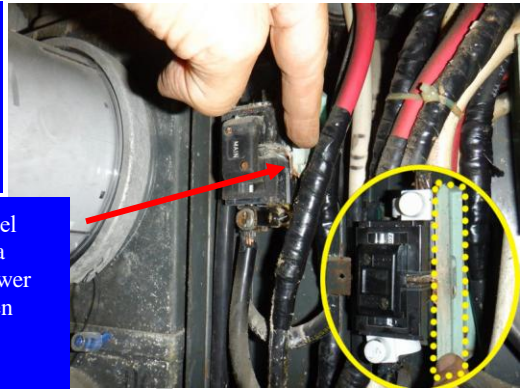
...the right service panel upper left breaker has a damaged guard (the lower half is chipped off when compared to another)

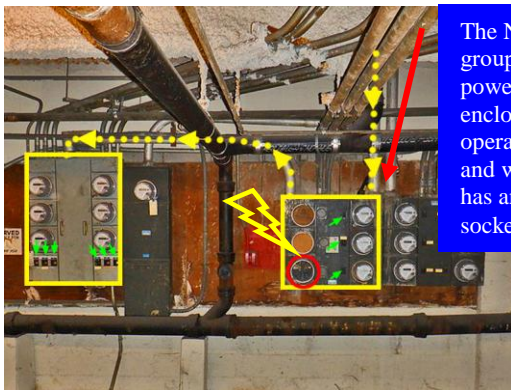
- Safety Issue:** The NW-electrical service group has three abandoned meter sockets of which two have been capped-off and where the remaining open meter socket also be capped-off given the live electrical components exposed within this enclosure that present shock and arcing hazards.

The NW-electrical service group's left enclosure also powers an added meter enclosure that requires operating 3 more breakers and where the original panel has an un-capped meter socket containing live parts

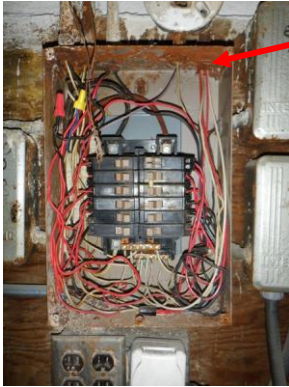
- Safety Issue:** The pool equipment electrical panel has subjected to chronic water saturation from overhead patio planters (since removed and filled) that resulted in corrosion within the panel where the circuit breakers may have been exposed to water which in turn would damage their internal components. A licensed electrical contractor should review this panel, test the breakers for over-current protection, etc. Note: this panel also has 'double-tapped' breakers where pairs of conductors are terminated at single breaker lugs when only one conductor is usually allowed to assure proper torque and load ratings that otherwise present arcing hazards.

The pool equipment area electrical panel is corroded...

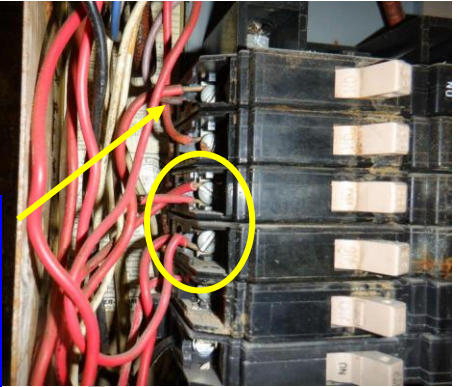
...and contains multiple 'double-taps'...

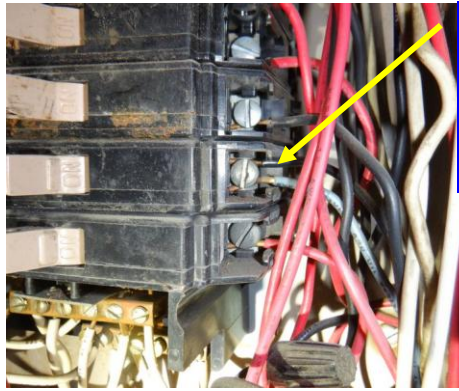
...that must be separated...

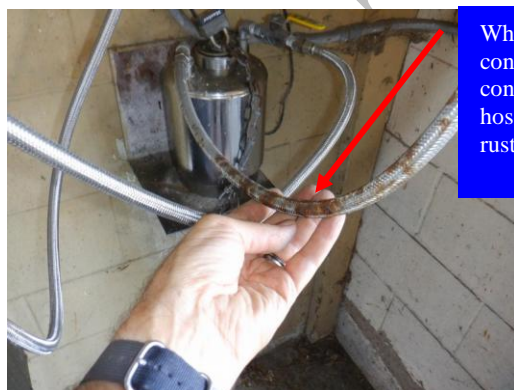
What appears to be a concentrated water conditioning system feeder hose at the water main is rusting

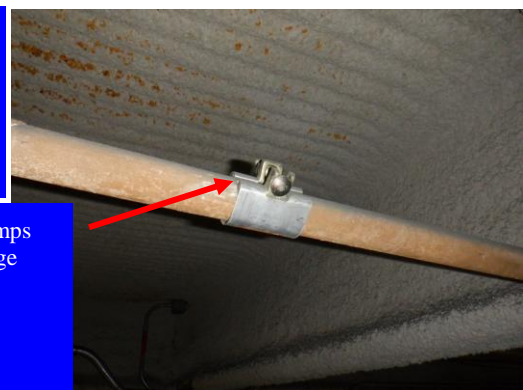
Water supply leak clamps were noted at the garage near column #26...

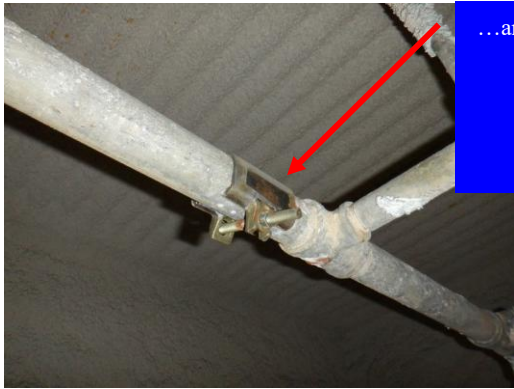
...and near column #8...

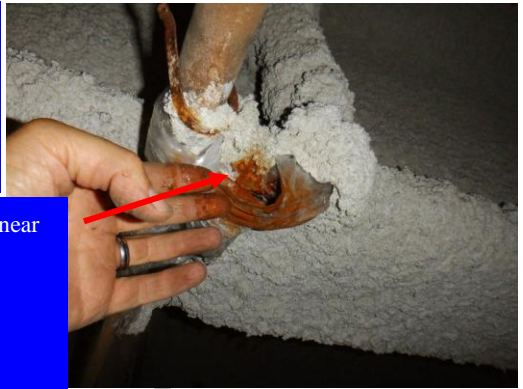
Leaks were also noted near column 29...

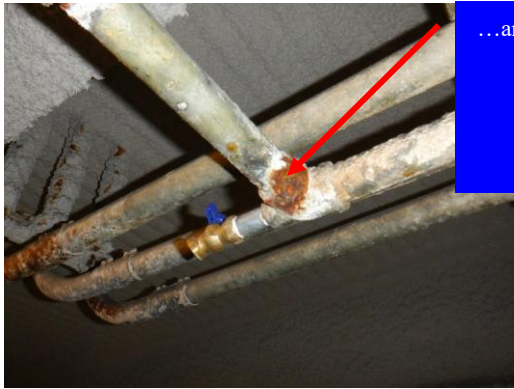
...and other location

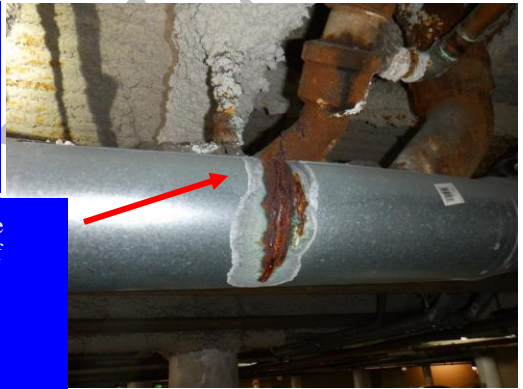
The waste piping in the garage has a number of leaks...

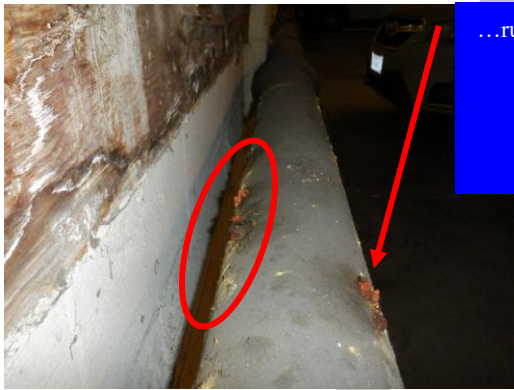
...rust blossoms...

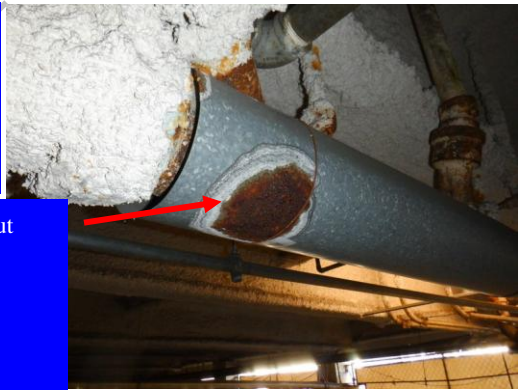
...that were shielded but not corrected...

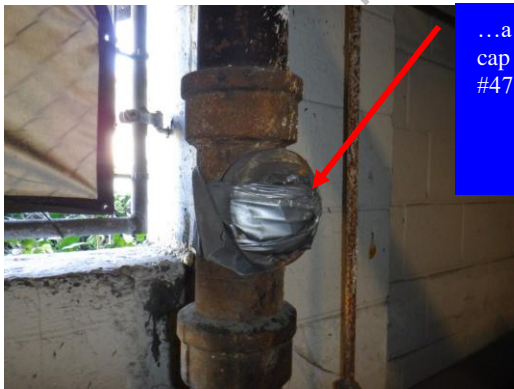
...a damaged waste pipe cap was noted near column #47...

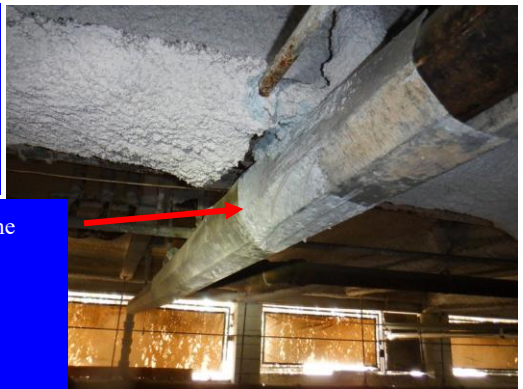
...again, shielding of the waste piping...

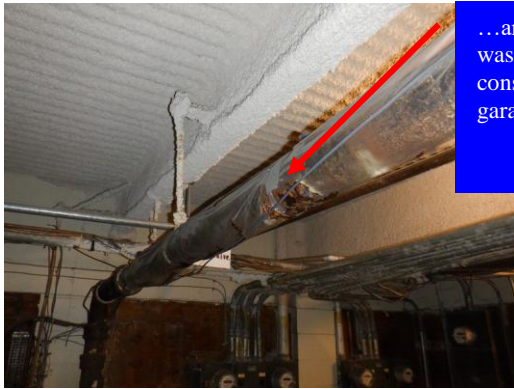
...and wrapping leaking waste pipes were conspicuous throughout the garage...

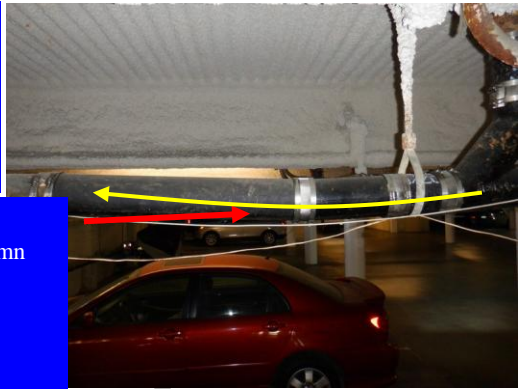
...other issues include sagging pipe near column #8...

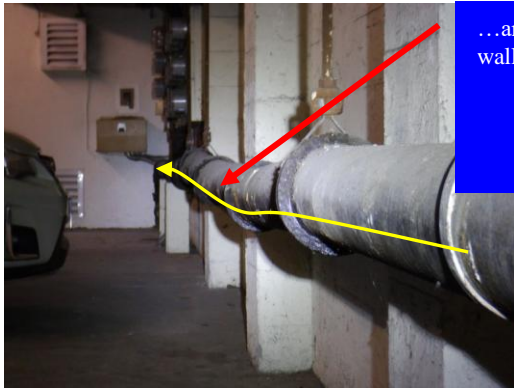
...and along the garage N-wall

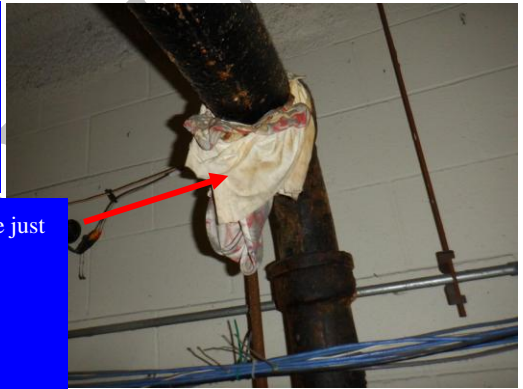
Some leaking joints are just packed with additional material

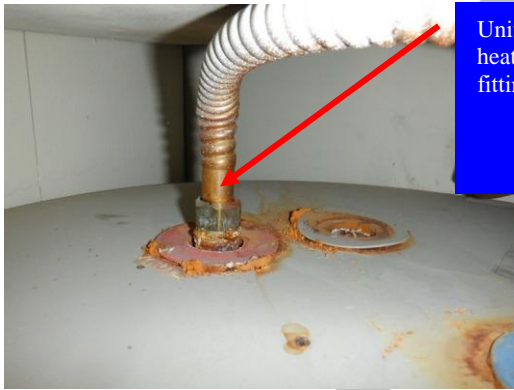
Unit #304: The water heater has corroded fittings...

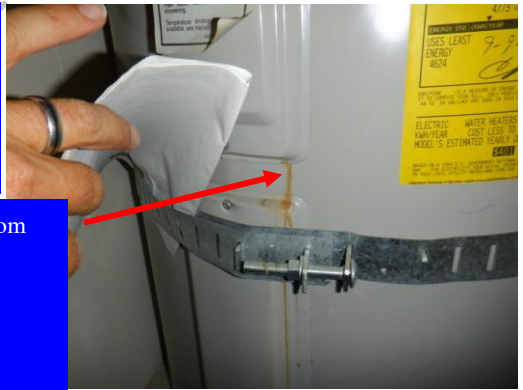
...and signs of leaks from the cabinet

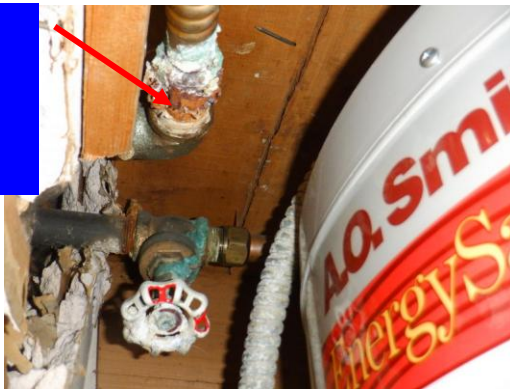
Unit #304: The water heater fittings are leaking

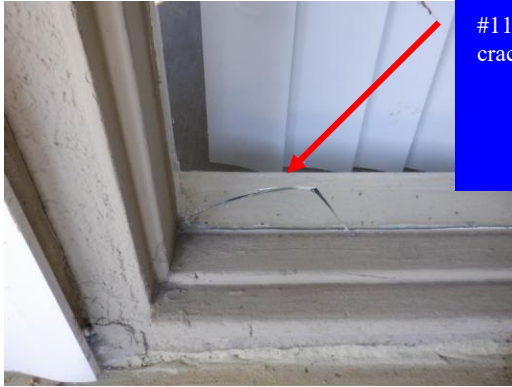
#110: The balcony has a cracked window pane...

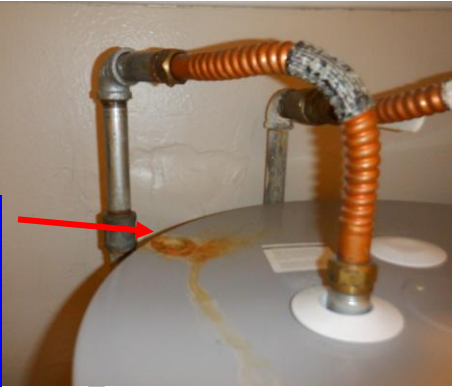
...the water heater has a leaking pipe fitting...

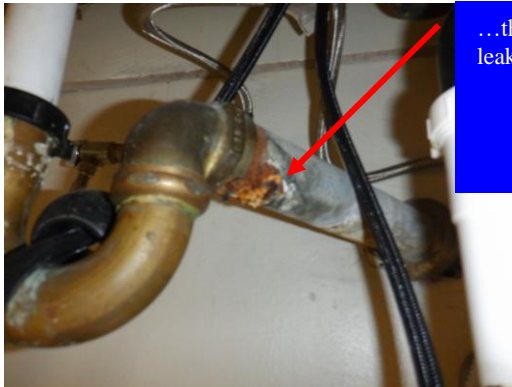
...the kitchen sink has a leaking drain...

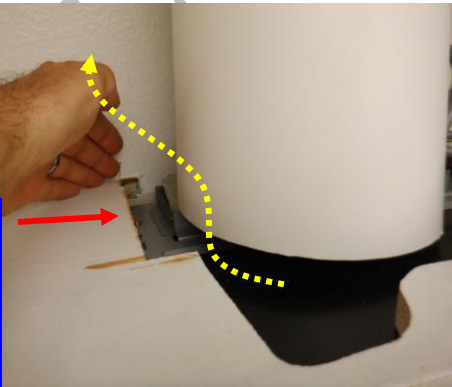
...and the kitchen exhaust fan is not connected to the duct and so discharges to the cabinet

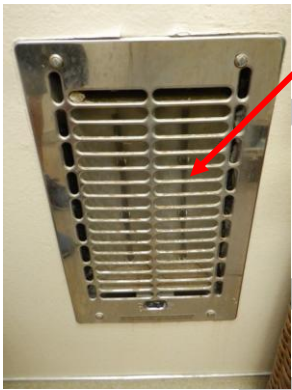
1. **Safety Issue:** Suggest removal or disconnection the bathroom wall mounted resistance coil heaters as they present a burn and fire potential given their exposed high temperature components.
2. **Note:** All radiant heating zones inspected at the six dwelling units that were entered responded to normal operating commands. No improvements are needed at this time. Never puncture the ceiling finish as damage to the imbedded heating system wiring grid is likely and very difficult to repair.

#114: The wall mounted coil heaters noted here and at other units must be removed...

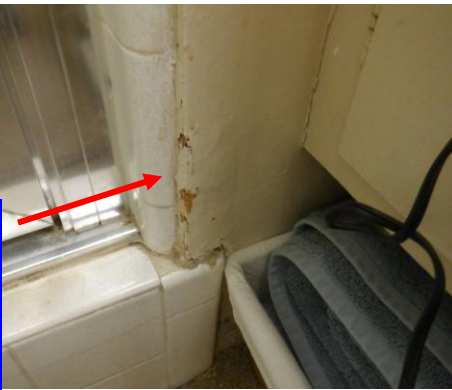
...the wall adjacent to the master shower shows water damage...

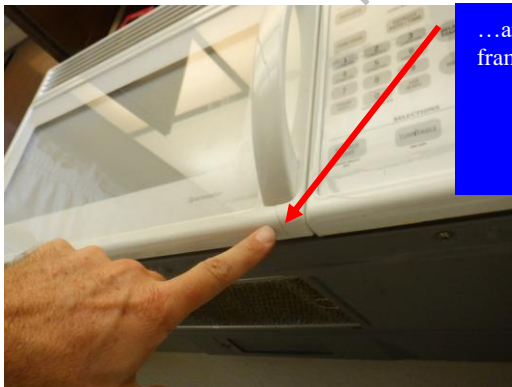
...and the microwave door frame is cracked

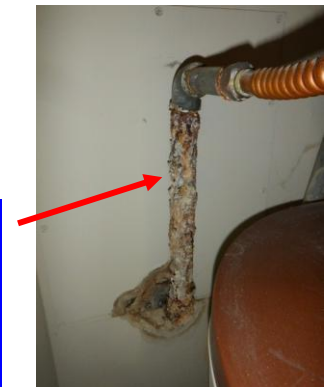
#201: The water heater hot water pipe is heavily corroded...

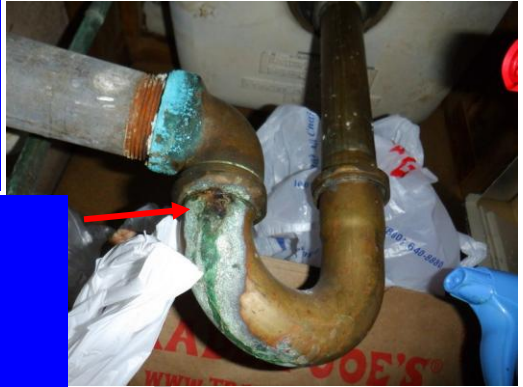
...and the kitchen sink cabinet has damaged rear wall finishes...

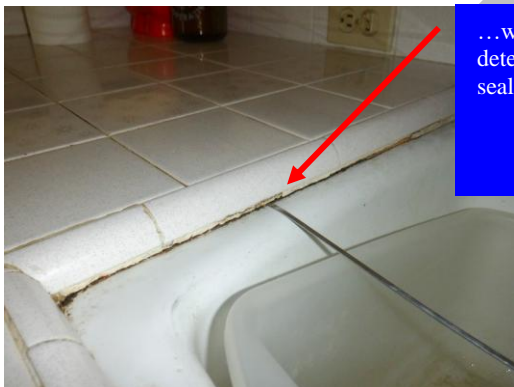
...and cabinet water damage...

...where the sink's deteriorated perimeter sealant may be a factor

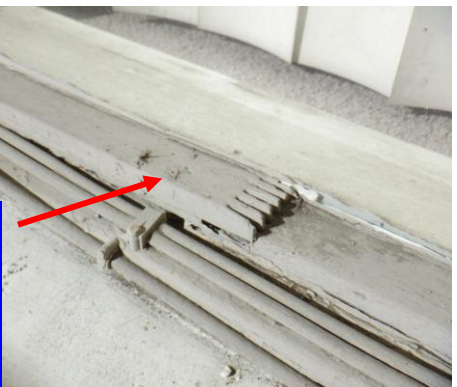
#307: The balcony window wood trim is weathered...

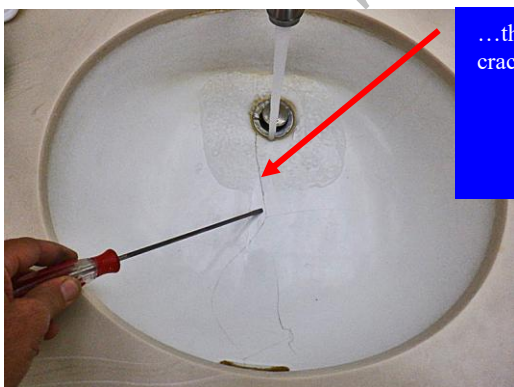
...the bathroom sink is cracked...

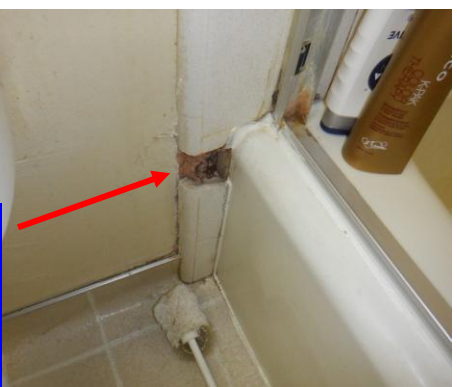
...the wall adjacent to the tub/shower is damaged...
