# Commercial Building Inspection Report

## Major Components Only

Long Beach, CA

**Inspection Date:**  
December 2018

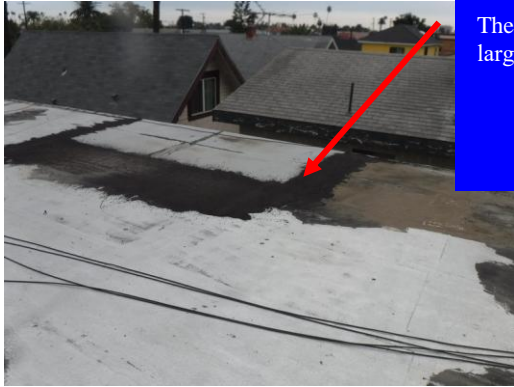
The roof has a number of large patched areas...

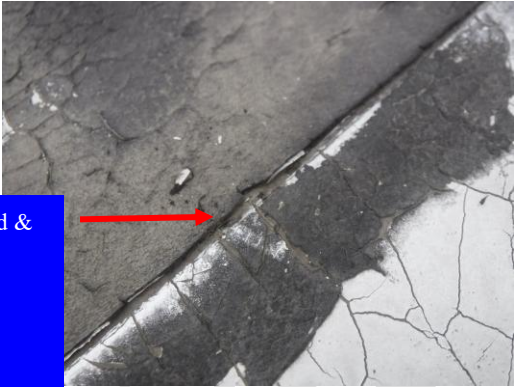
...lifting seams, cracked & crazed surface...

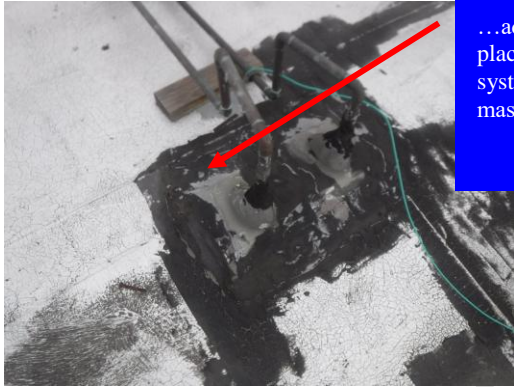
...added jack flashings placed atop the roofing system and sealed with mastic...

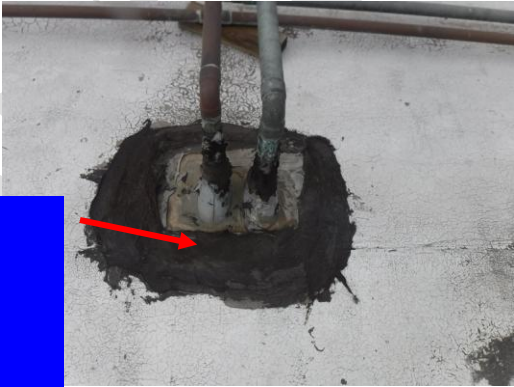
...when an overlay of roofing is preferred

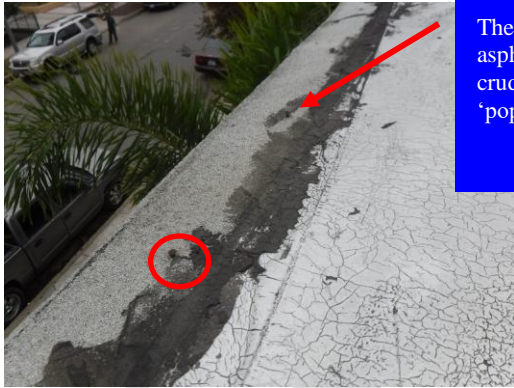
The perimeter transitions to asphalt based roofing has crude sealant details, 'popped' fasteners...

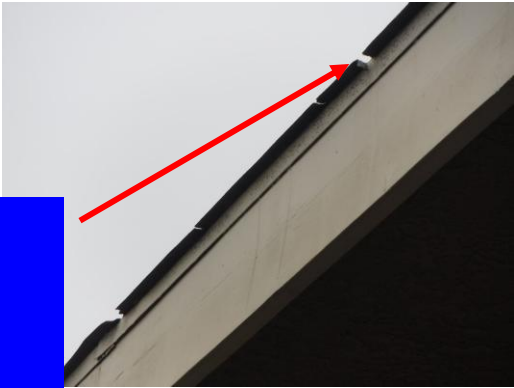
...and damage due to excessive over-hang

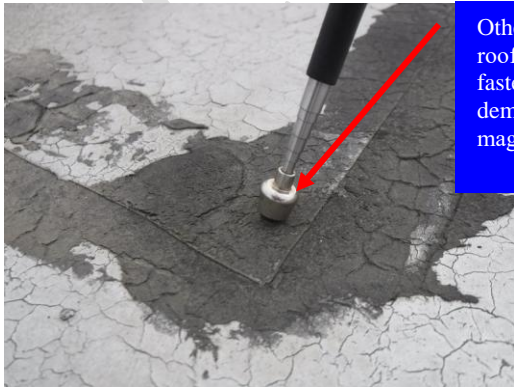
Other patched areas of the roof have 'popped' fasteners here demonstrated with a magnet...

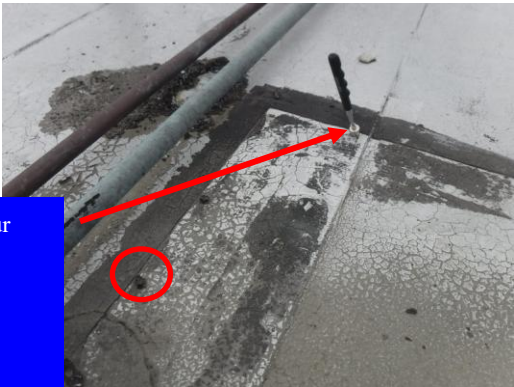
...where leaks can occur

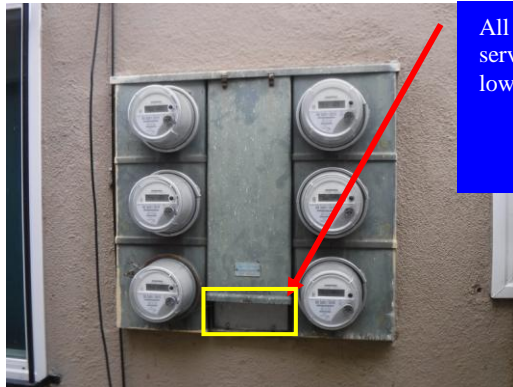
All three of the electrical service panels are missing lower outer covers

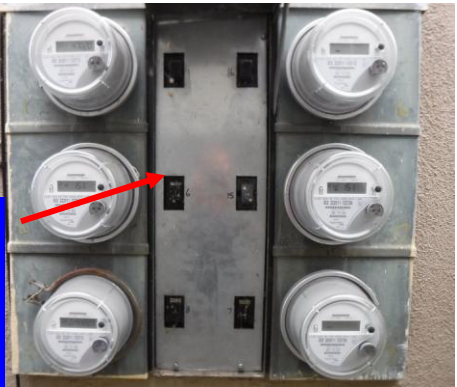
The N-wall center electrical service has an on-site fabricated dead-front cover

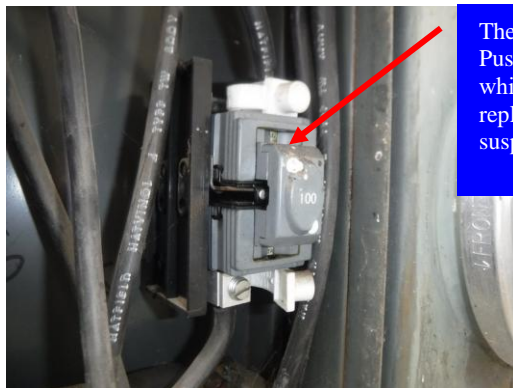
The panels use problematic Pushmatic breakers of which some are 'newer' replacement units with suspect performance

- Major Concern/Safety Issue:** The three main electrical service panels are “Bulldog” units using older-style disconnects that function by pushing a button (not ‘throwing’ a toggle). These types of breakers have well documented quality and performance issues that have earned them a reputation as being unreliable to shut-off power when needed. As well, their unique ‘on/off’ indicators consist of a ‘window’ where a rotating ‘on/off’ labeled drum is operated by a ratchet system that itself can jam the button from tripping as well as become damaged to where the indicator will read ‘off’ when ‘on’ or, the labels can be worn-off preventing a clear determination as to the status of the circuit. Further, replacement breakers (having a light gray housing) are typically cheap manufactured imports that do not meet required listing/performance standards. Finally, some of the breaker mounts have damaged insulation guards, appear deformed, and have on-site fabricated ‘dead front’ covers as well as missing lower outer covers (where water can enter). These services are considered deficient in numerous areas and should be replaced by a licensed electrical contractor.

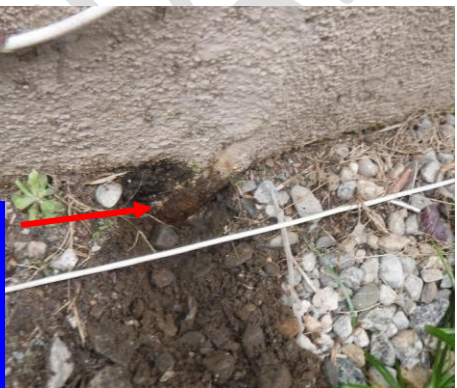
The electrical services buried earth grounding electrodes have corroded conduits below grade

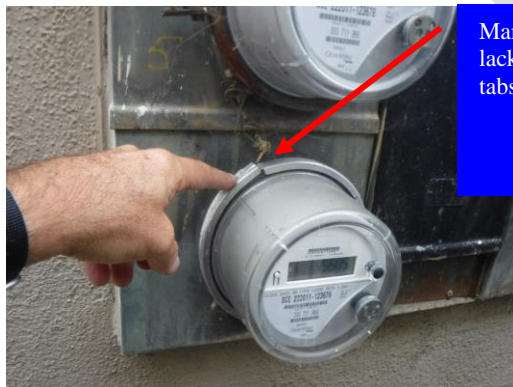
Many of the service meters lack utility provided lock tabs

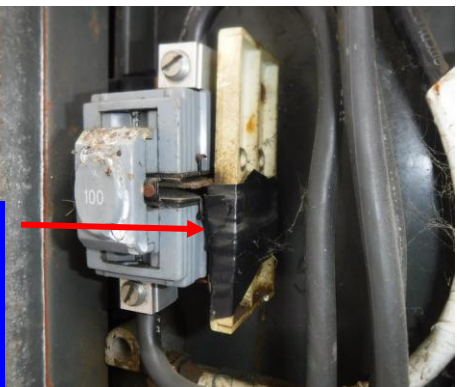
Some of the service panel breakers have damaged insulation guards (here held with tape)

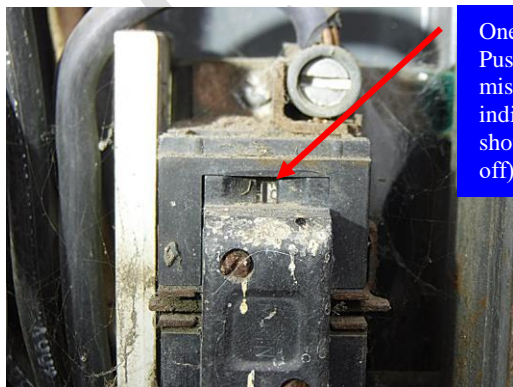
One of the issues with Pushmatic breakers is misaligned 'on/off' indicators (this one is showing half on, half off)...

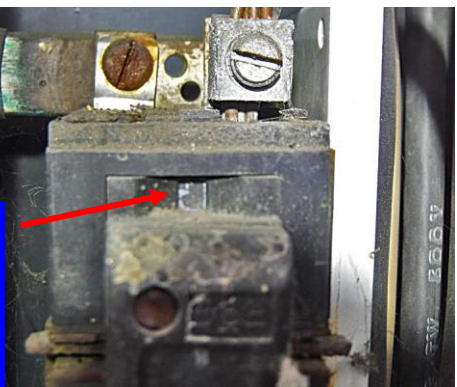
... while others have the indicator labels worn off

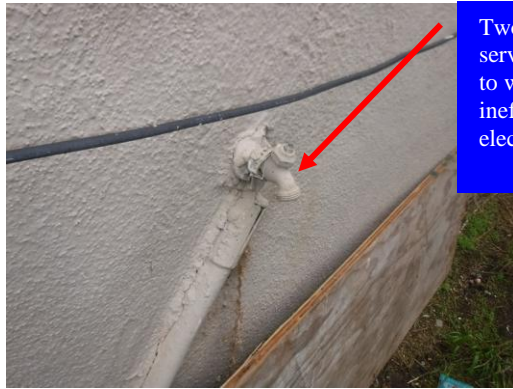
- Safety Issue:** The three electrical service panels appear to have their earth grounding conductors connected to water piping where potential issues exists: The NW & SW electrical services may well be grounded to abandoned/unused galvanized water supply pipe that could be cut-away from the plumbing system and no longer provides a continuous path to earth. Further, the buried rigid steel conduit protecting the earth grounding conductor could be heavily rusted and fallen apart where an arc-flash can occur during a high voltage event that can cut the grounding conductor itself resulting in dangerous voltage levels remaining upon the electrical system; suggest immediate further investigation and repairs as needed by a licensed electrical contractor.

Two of the three electrical service panels are grounded to what could be ineffective water pipe earth electrodes

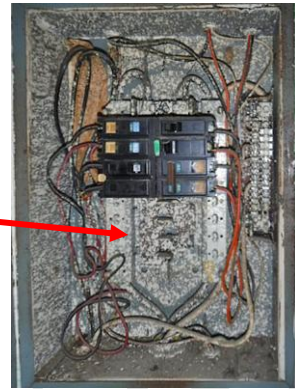
- Safety Issue:** Paint over-spray was noted at the four electrical distribution panels inspected which is likely indicative of similar conditions at the balance of panels. Paint is not allowed within panels and is difficult to correct as cleaning solvents may not be used (panel/bussing replacement is the only option) given the paint can interfere with proper contact between conducting materials and cause them to overheat. An electrician must immediately review each panel within the building for possible problems.

Unit #1: All three panels inspected have been covered with paint

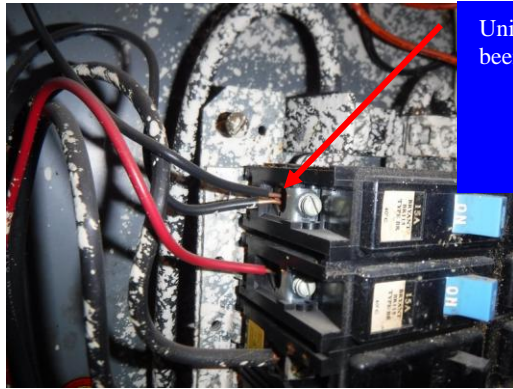
7. **Safety Issue:** The Unit #10 electrical panel has two circuit conductors that are doubled up (referred to as "double taps") to a single breaker and must be separated. Each circuit conductor is to be served by a separate breaker; suggest repairs by a licensed electrical contractor.

Unit #10: A breaker has been double-tapped

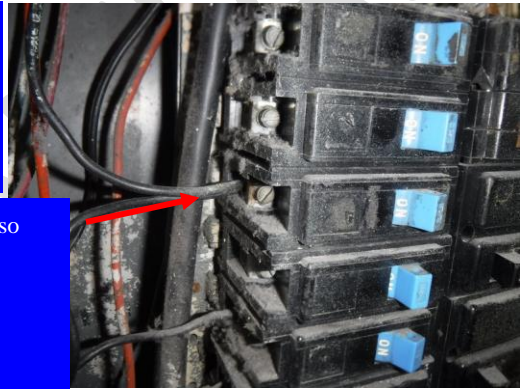
Laundry: This panel also has a 'double-tapped' breaker lug...

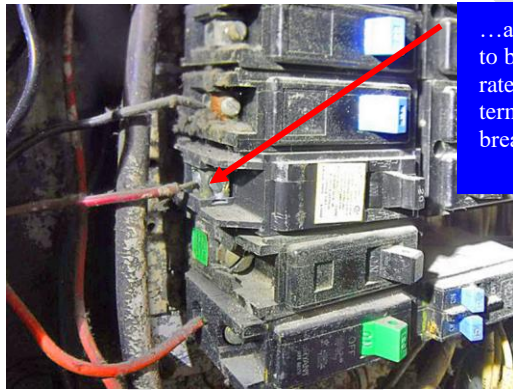
- Safety Issue:** The laundry area electrical panel has a number of unsafe conditions presenting shock & fire hazards including: two oversized breakers (a 20amp breaker serving a 14-gauge conductor rated for just 15amps, a 50-amp breaker serving a 12-gauge conductor rated for just 20-amps), pointed screws that can pierce wiring are securing the cover, there is an unused breaker opening, two circuit conductors are doubled up (referred to as “double taps”) to single breaker lugs that must be separated (each circuit conductor is to be served by a separate breaker) and added vinyl-clad distribution cable passing through panel frame opening lacks a bushing; suggest immediate repairs by a licensed electrical contractor.

...as well as what appears to be a 14-gauge conductor rated for 15-amps terminated at a 20-amp breaker...

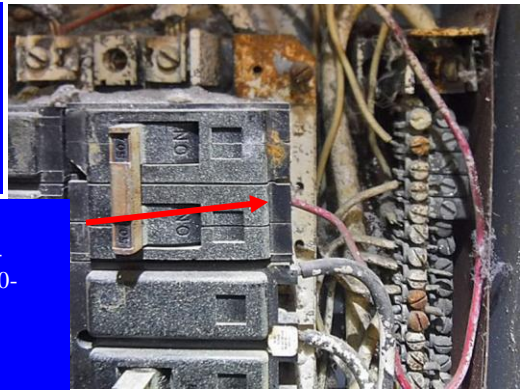
...and a 12-gauge conductor rated for 20-amps terminated at a 50-amp breaker...

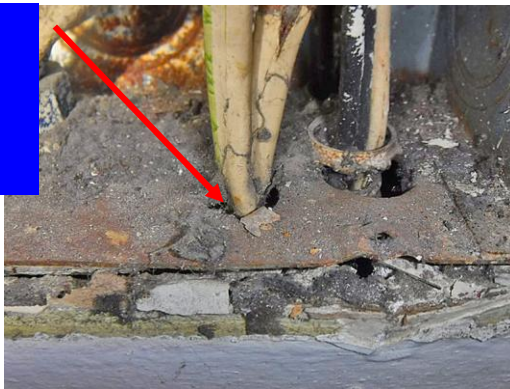
...along with added distribution cable routed through the panel where a bushing is needed

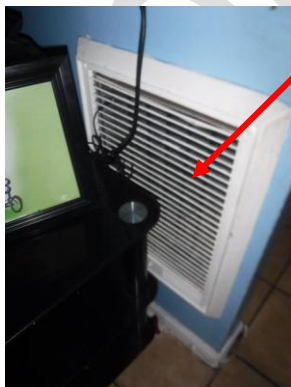
- Major Improve/Safety Issue:** Suggest removal/replacement of the wall mounted electric resistance coil heaters as they present a burn potential given their exposed high temperature components. As well, a few units did not respond, others have damaged grills/covers that expose the heating elements to contact with furnishings/storage/occupants, etc. Ideally, these should be replaced with baseboard units or wall mounted fan driven units. Note: Additional heating may be needed at some dwelling units; suggest further improvements as needed by a licensed heating/cooling contractor.

The heating units are electrical resistance coil units of which two were inoperative...

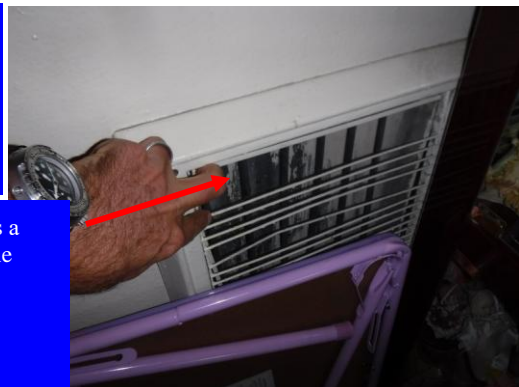
...and the #10 Unit has a damaged grill where the coils are accessible

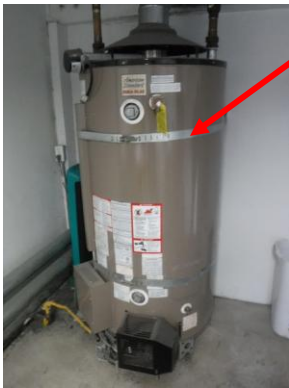
The 100 gallon water heater only has two seismic straps...

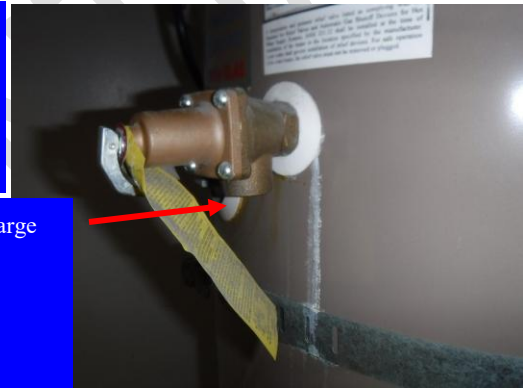
...and a missing discharge pipe at the TPR valve

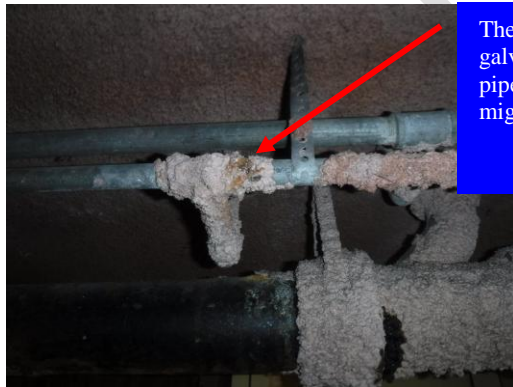
The #6 garage has galvanized water supply pipe showing corrosion that might be abandoned

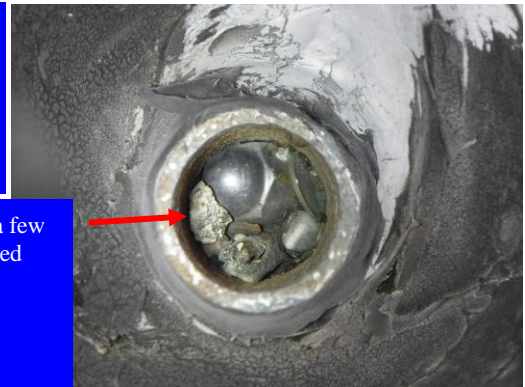
- Improve:** The waste system vent stacks at the rooftop where inspected of which at least two of the smaller vents were full of debris preventing the system from proper function that can lead to drain back-ups, gas build-up, etc., and require immediate repairs by a licensed plumbing contractor.

The waste piping has a few rooftop vent stacks filled with debris...

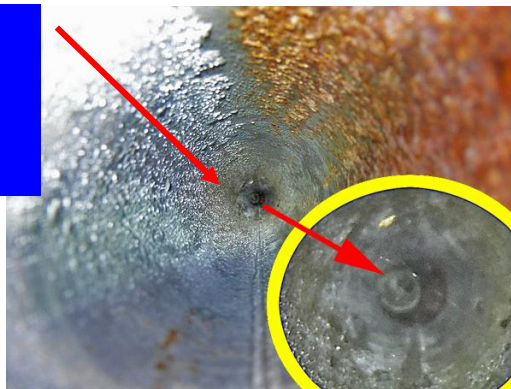
...that can affect proper drainage of the fixtures

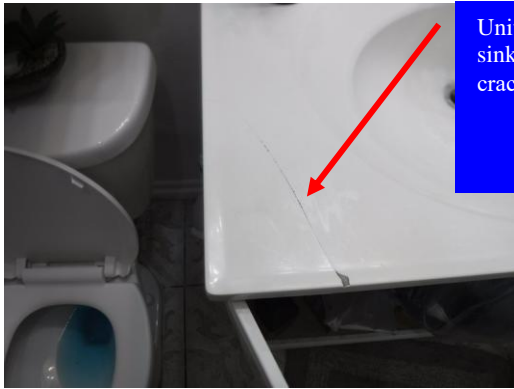
Unit #1: The bathroom sink/countertop is cracked...

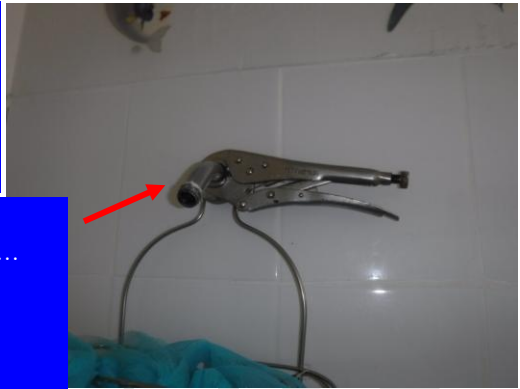
...the shower neck is secured with vise grip...

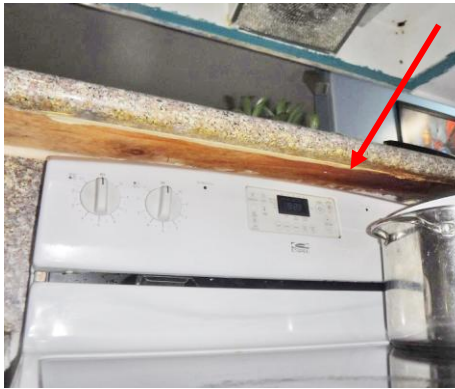
3. **Safety Issue:** The kitchen peninsula's countertop has a exposed, combustible wood 'rough-top' just above the electric range that presents a fire hazard and requires proper thermal shielding; suggest improving as needed by a licensed contractor.

...the kitchen peninsula's combustible wood rough top hangs over the cooktop console and shows heat damage

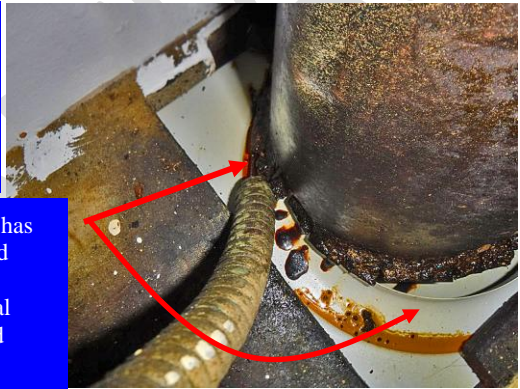
1. **Safety Issue:** Improper wiring noted at the kitchen exhaust hood where distribution wiring is spliced directly to light-duty lamp cord within the over head cabinet that presents a shock & fire hazard (compounded by the build-up of food oils/grease upon the wiring) that requires immediate repairs by a licensed electrical contractor.

...the exhaust fan duct has separated allowing food oils/grease within the cabinet and its electrical has exposed wiring and connections...

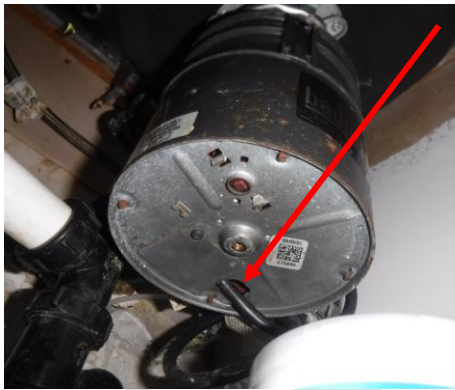
... the disposal unit power cord lacks a bushing

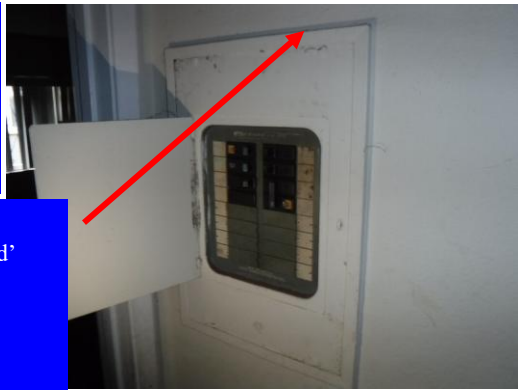
Unit #4: The electrical panel cover is 'captured' within an added steel frame...

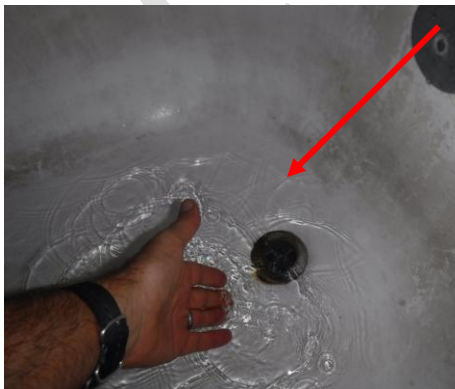
...the tub drain has backed-up...

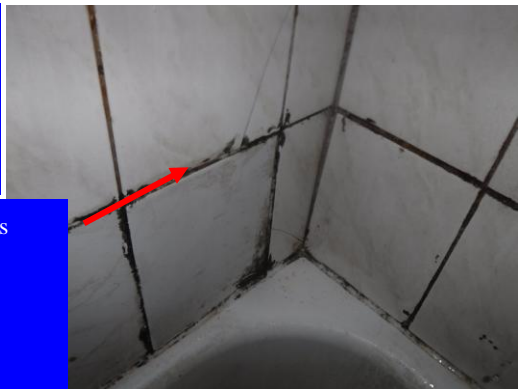
...and the enclosure has damaged tile...
