Building Inspection Report

Palos Verdes Estates, CA

Inspection Date:
2019

Prepared By:
Beachside Property Inspection, LLC
5318 E. 2nd St., #707
Long Beach, CA, 90803
ph. (562) 433-2288

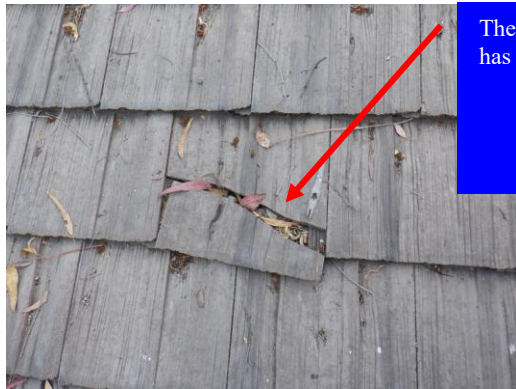
The garage roof E-slope has a separated tile...

- **Improve:** Minor repairs and maintenance to the roofing is needed. Damaged roofing material noted at the garage E-slope should be repaired, the gas appliance exhaust vent pipe jack flashings provided storm collars (here, the roof jack flashings were simply sealed to the vents and missing storm collars) and built-up foliage noted here and there that must be removed; suggest repairs by a licensed roofing contractor.
- **Improve:** A rain cap and vermin screen should be installed on the masonry chimney.
- **Improve:** Gutters and downspouts are needed to control roof water. The downspout(s) should discharge water at least five (5) feet from the house. Storm water flow away from the building at the point of discharge.

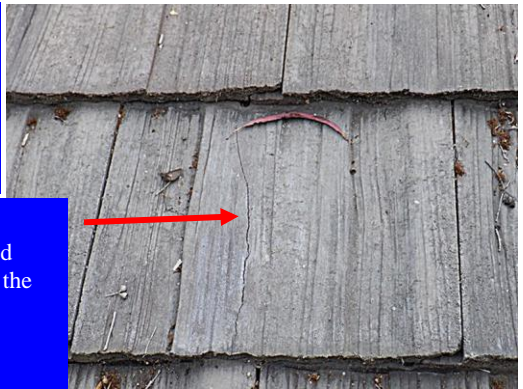
...and other tiles were noted to have developed cracks such as again at the garage E-slope...

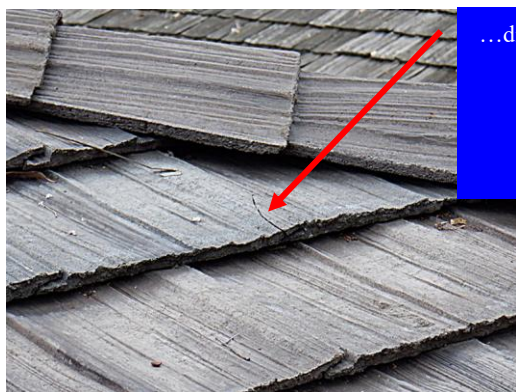
...dining area NW-hip...

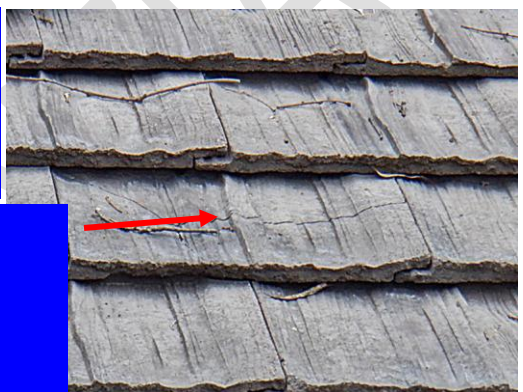
...and foyer area

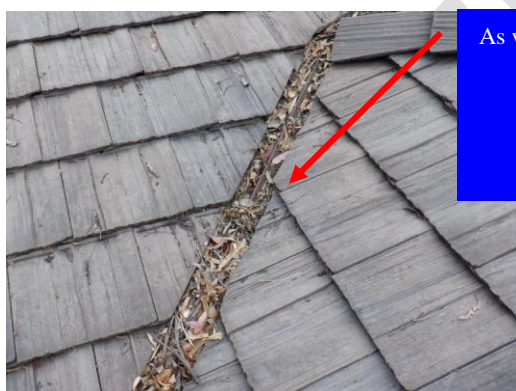
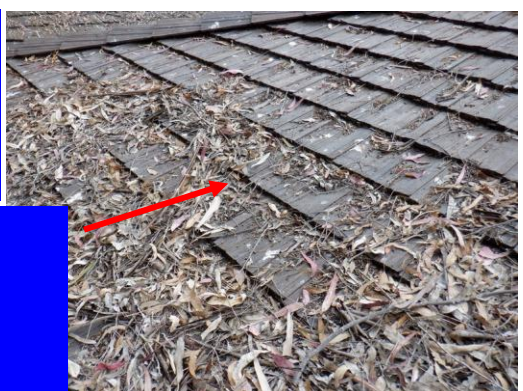
As well, built-up foliage...

...must be removed

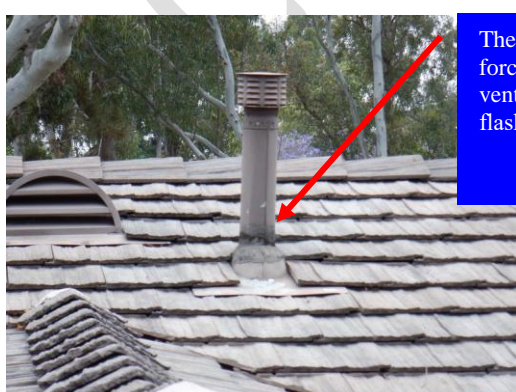
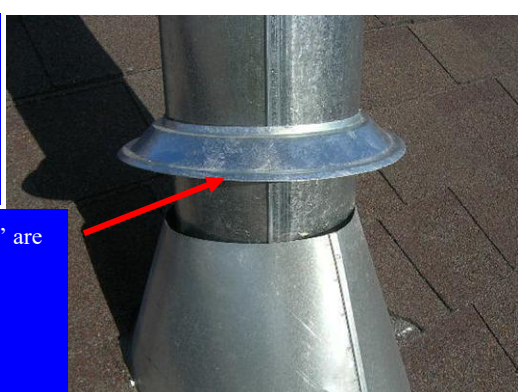
The water heater and forced air heater exhaust vent pipes are sealed to the flashing...

...where 'storm collars' are preferred

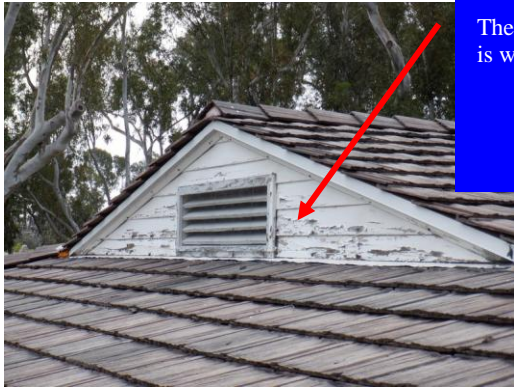
The W-gable wood siding is weathered...

- **Improve:** The wood siding at the dining room W-facing gable and at the water heater closet door/trim shows considerable deterioration that will require (in various degrees) replacement, repair, and paint. Suggest a review of the pest report for the condition of this and all wood.

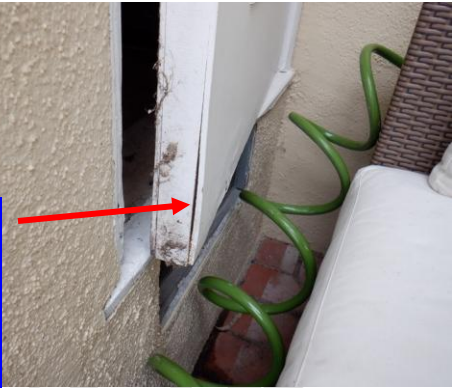
...the water heater closet door and casing are damaged...

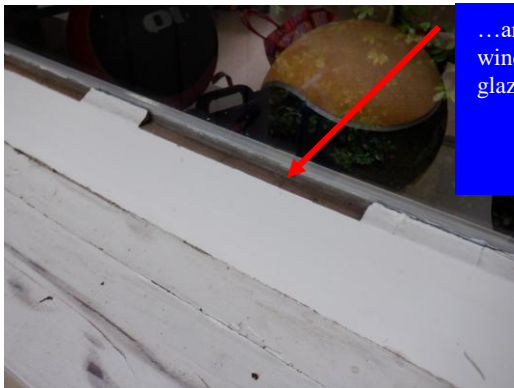
...and some of the windows are missing glazing

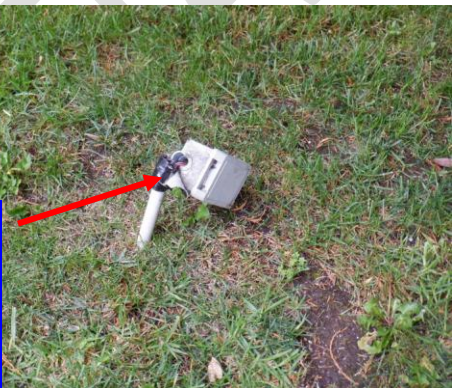
The front lawn has damaged electrical fixtures...

- **Safety Issue:** The front yard has electrical boxes at the grass area that lack steel support stakes, have damaged conduit and exposed wiring presenting shock hazards. As well, the N-bedroom exterior wall has a damaged/rusted apart electrical conduit routed to the soil; suggest repairs by a licensed electrical contractor.

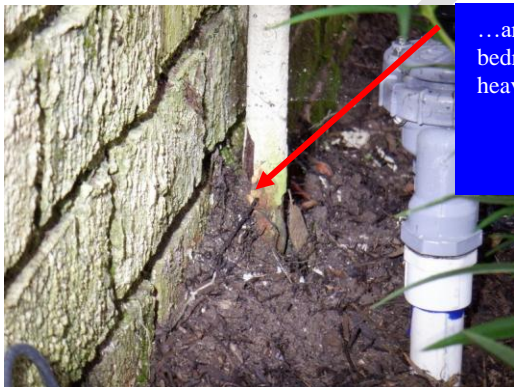
...and a conduit at the N-bedroom N-exterior wall is heavily corroded

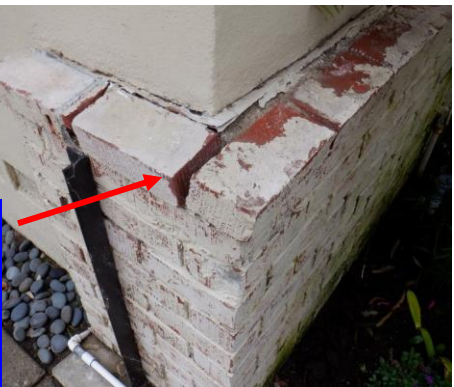
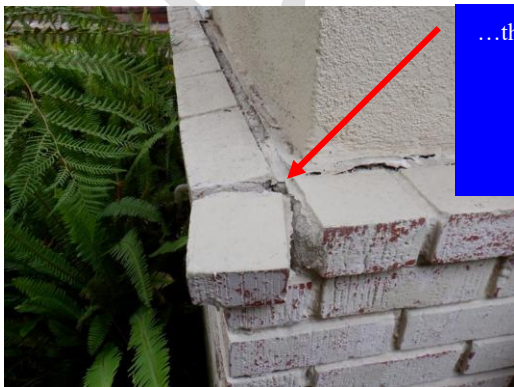
The exterior wall brick skirt has a few loose bricks...

...that should be secured

25. **Improve:** The N-facing exterior wall lower brick skirt has a few loose bricks, missing flashing at its upper course and appears to be soaked by sprinkler spray at the N-bedroom area; suggest repairs by a licensed contractor.

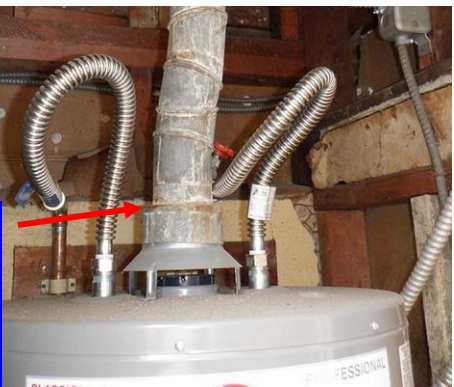
The water heater exhaust venting system has a reducer fitting and re-uses the corroded vent pipe that served the previous water heater

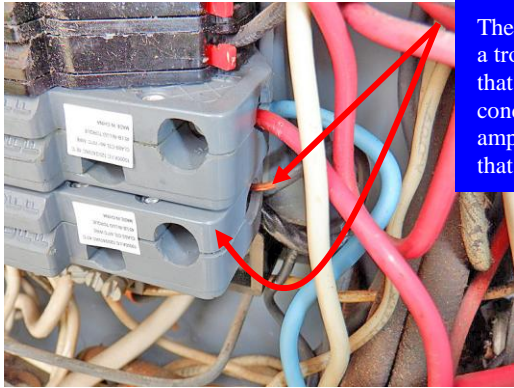
The main electrical panel is a troublesome 'Zinsco' unit that also has a 14-gauge conductor rated for 15-amps at a 20-amp breaker that itself is off-set

- **Safety Issue/Major Improve:** The "Zinsco-Sylvania" main electrical panel is an older component with known reliability issues that feature both breaker and buss-bar configurations/design long abandoned by manufactures. Further, the performance/reliability of these older units is considered to be fully depreciated and their 'new' replacement parts are cheap imports lacking certification and so the unit should be *immediately replaced* by a licensed electrical contractor. Other issues noted here are the dangerous pointed screws fastening the cover (that can pierce wiring), unused conduit openings that should have been capped and what appears to be a 14-gauge conductor rated for 15 amps terminated at a 'newer' breaker rated at 20-amps (further, one of the newer breakers is off-set atop the mount). As well, the panel's ground conductor is connected to an abandoned galvanized water supply pipe as an earth electrode that is longer be apart of the water distribution system (now copper piping) which prevents the electrical system from having the required earth grounding feature--*Grounding is an essential component of the electrical system the lack of which presents immediate hazards.*

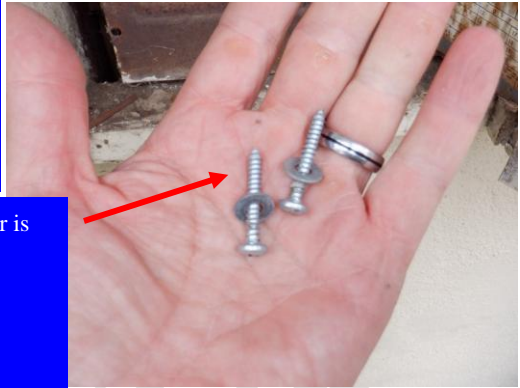
Further, the panel cover is fastened with pointed screws...

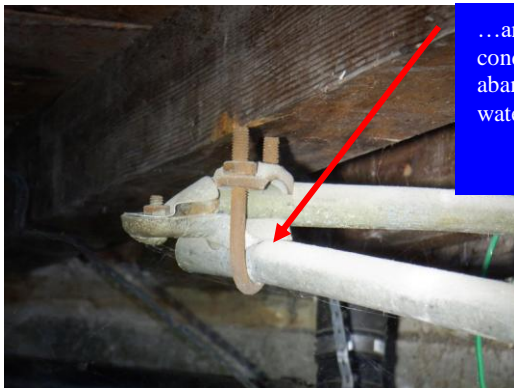
...and its earth grounding conductor is terminated at abandoned galvanized water pipe

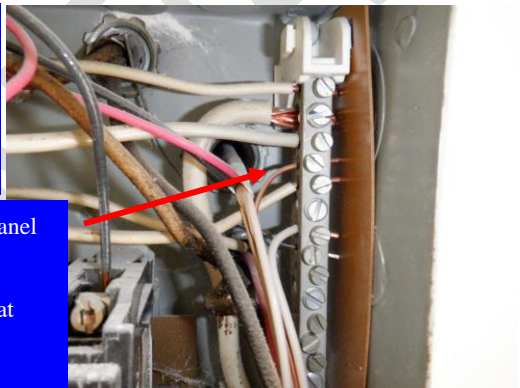
The garage electrical panel has a bare copper 'equipment grounding conductor' terminated at the neutral bar

- **Safety Issue:** The garage electrical panel has the improper termination of branch circuit grounding conductors (either having green insulation or bare copper) noted at the neutral bar which presents shock & fire hazards. Branch circuit grounding conductors (also referred to as equipment grounding conductors) at a branch electrical panel must be separated from the neutral bar, bonded to the panel frame and provided a dedicated feeder/path to the main panel. The improper configuration noted here can defeat the shock protection/safety features of the system and present shock hazards; suggest repairs by a licensed electrical contractor.

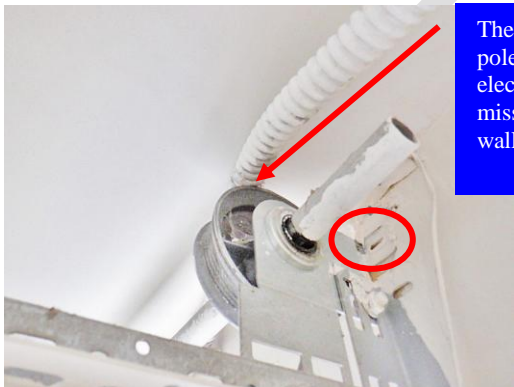
The vehicle door S-torsion pole drum is rolling against electrical conduit and missing lag screws at the wall mount

- **Safety Issue:** The garage vehicle door springs require adjustment for easier manual operation to prevent the potential for injury or an obstruction for a single individual to remove a vehicle from the garage should the opener become inoperative (note: a battery back-up may be available). Further, the garage door opener auto-reverse sensors must be re-located between 4 and 6 inches from the garage floor, missing bolts at the garage vehicle door torsion rod's outside mounting brackets require installation, an electrical conduit is contacting the torsion pole cable spool that is abrading the conduit, the garage vehicle door's automatic opener requires a carriage release handle located 6-feet above the floor, manufacture warning labels are needed (at the spring assembly, vehicle door center section as well as it's lower corners and adjacent to the wall button); suggest improving as needed by a licensed specialist.

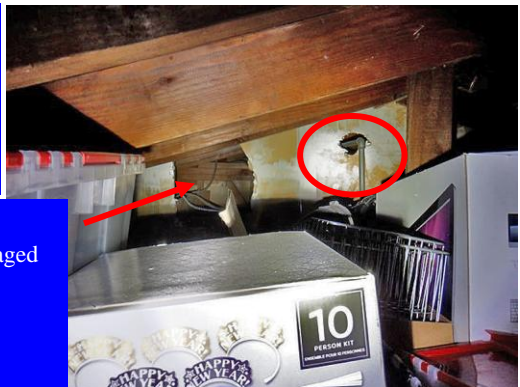
The garage attic fire separation wall is damaged

- **Safety Issue:** Proper fire separation between the garage and house is required. Damaged fire-rated wall finishes noted at the garage attic must be patched with fire rated sheetrock. Further, any gaps should be filled and pipe penetrations sealed tight around their perimeter where they pass through the wall; suggest repairs by a licensed contractor.

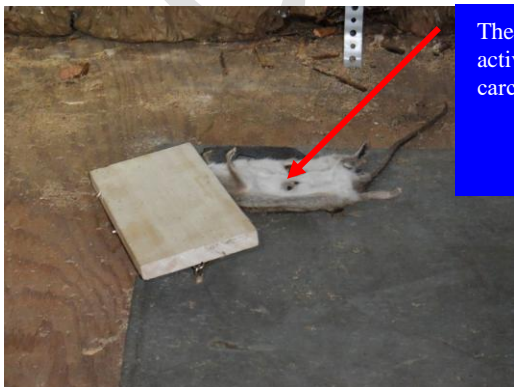
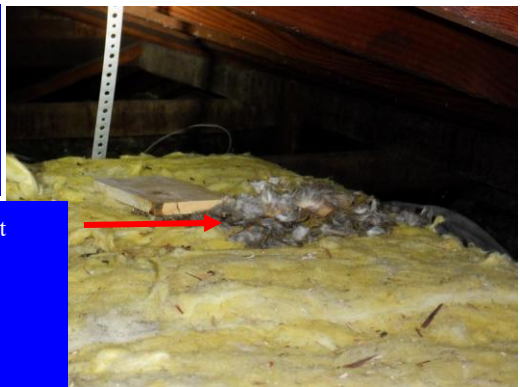
The attic has vermin activity given the two carcasses...

...and remnants present

- **Improve/Safety Issue:** Vermin activity noted within the attic space (droppings, carcasses, urine stains/odor, nesting, traps, etc.) requires remediation and prevention of all harborage by a “Branch II” pest control specialist.

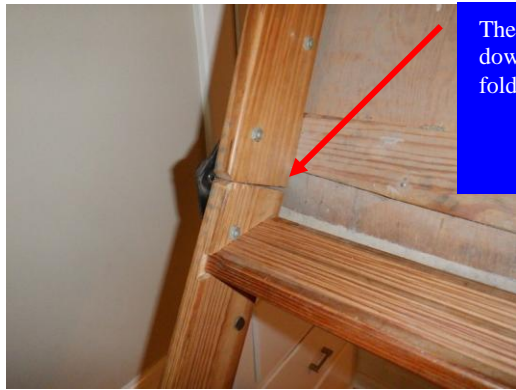
The hallway attic pull down ladder has a loose folding hinge

- **Safety Issue:** The hallway attic pull-down stairway has an over-extended folding hinge and splitting ladder rung that is due to improper sizing/trimming of the ladder where replacement is recommended by a licensed contractor.

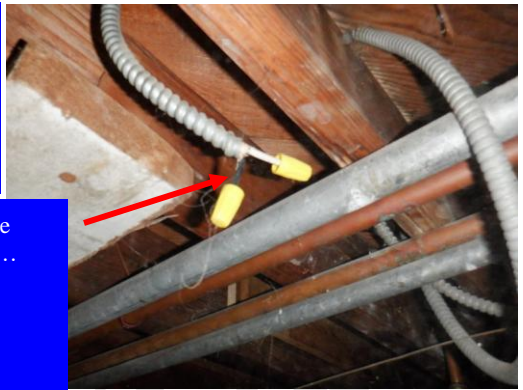
The kitchen crawl space has exposed wire ends...

- **Safety Issue:** The crawl spaces at the ¾-bath, kitchen & dining room have open electrical junction boxes as well as improperly terminated 'live' wire ends that present shock & fire hazards. All visible wiring connections and live cable ends should be enclosed within *covered junction boxes*; suggest repairs by a licensed electrical contractor.

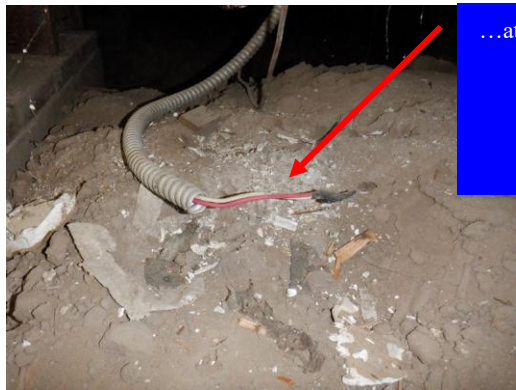
...at two areas...

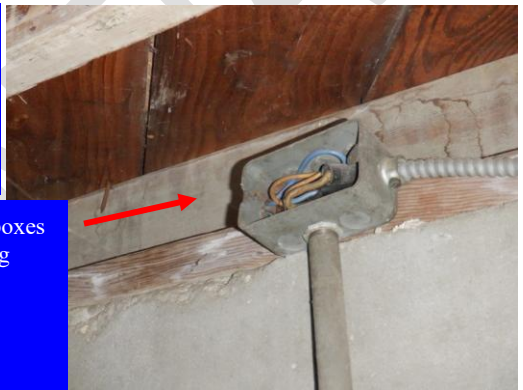
...and open electrical boxes were noted at the dining room crawl space...

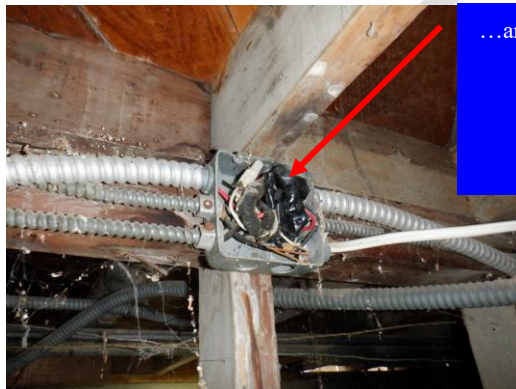
...and 3/4-bath crawl space

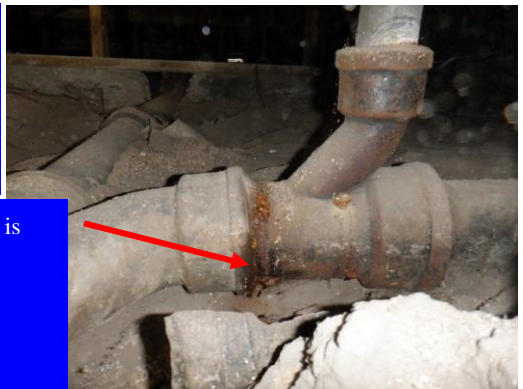
The older waste piping is exhibiting rust and corrosion

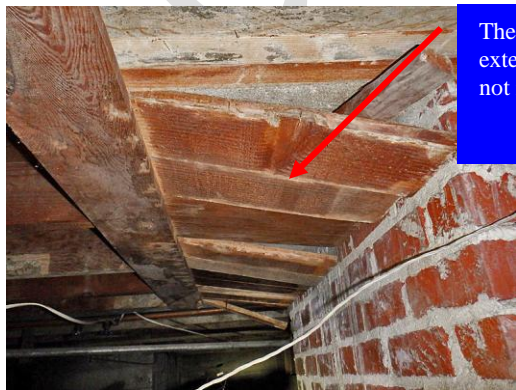
The fireplace hearth extension form boards were not removed

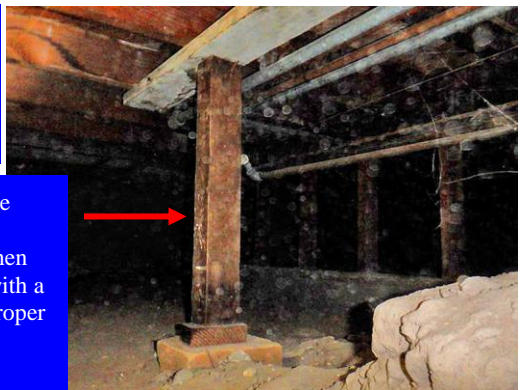
The kitchen crawl space has an added post with under-sized 'girder' when two posts are needed with a box girder as well as proper footings and framing hardware

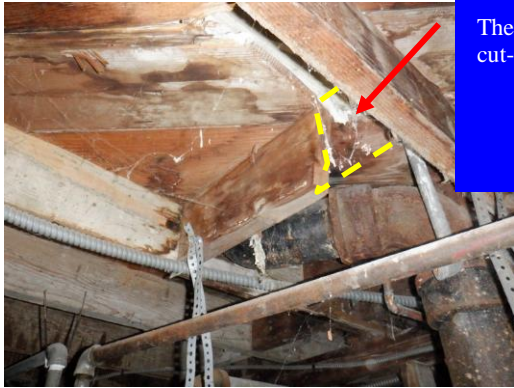
The 3/4-bath toilet area has a cut-through framing block

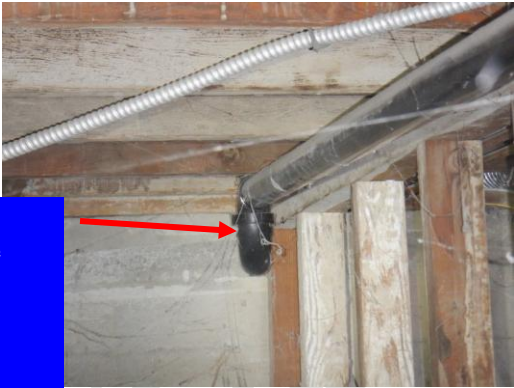
The laundry area waste pipe p-trap is below the floor...

24. **Improve:** The laundry area waste pipe p-trap is located within the crawl space and not above the floor level as is required. Further, the waste line does not appear to be provided a 'vent stack' needed to assure a vacuum does not develop within the pipe that blocks drainage; suggest repairs by a licensed plumbing contractor. Note: The possible solution is to remove the trap, extend the ABS waste pipe within the laundry area and add a 'tee' fitting downstream of the new p-trap upon which a riser pipe can extend vertically to a location above the washer and fitted with a air admittance device.

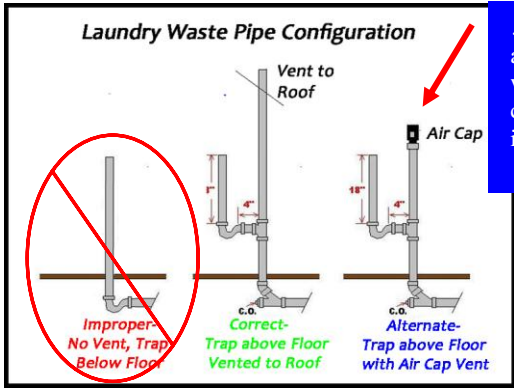
...which is prohibited as it also lacks a vent where the alternate configuration see here is an improvement

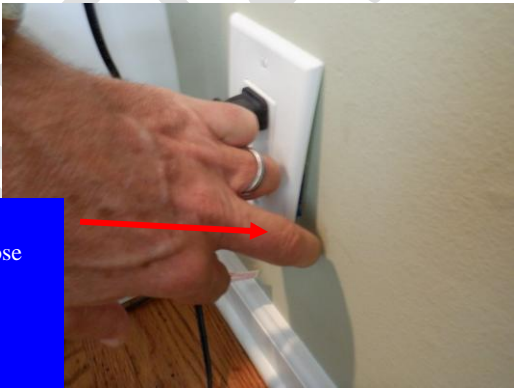
The N-bedroom NW-corner wall outlet is loose

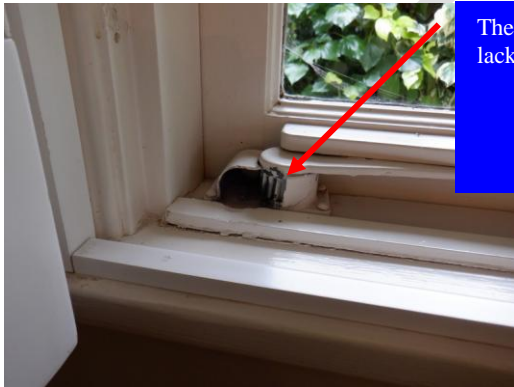
The dining area windows lack crank hardware

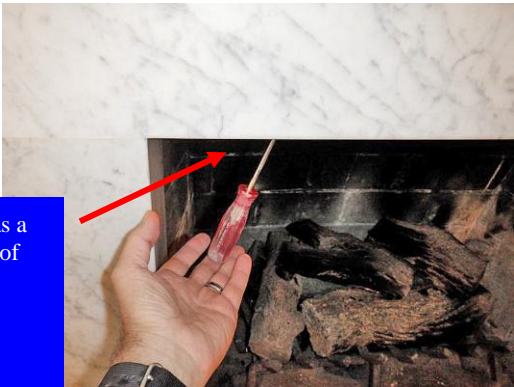
The fireplace mantle has a gap along the backside of its perimeter...

15. **Improve/Safety Issue:** The fireplace firebox and chimney are very dirty and has loose bricks at the rear wall. Further, there is a gap just behind the stone mantel that must be sealed, the out-dated aluminum gas connector replaced (given their propensity to leak) and a damper stop installed (a standard safety feature to minimize the possibility of exhaust gases entering the house). Further, the chimney inspectors report must be reviewed. Note: Repairs can be expensive. It is not unusual for specialists to discover additional defects that will require repair for the safe operation of this unit.

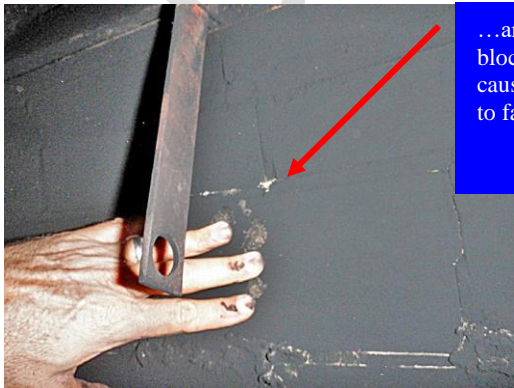
...and the loose rear wall blocks can be pushed causing powdered mortar to fall from the joints

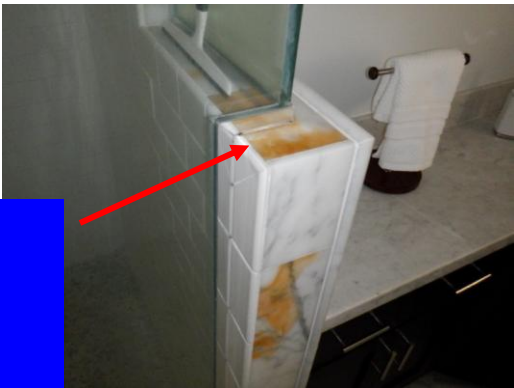
The full bath shower partition wall tile show water saturation
