Building Inspection Report

La Senda, Laguna Beach, CA

Inspection Date:
3/9/09

Prepared By:
Beachside Property Inspection, LLC
5318 E. 2nd St., #707
Long Beach, CA, 90803
ph. (562) 433-2288
fax: (562) 987-2424

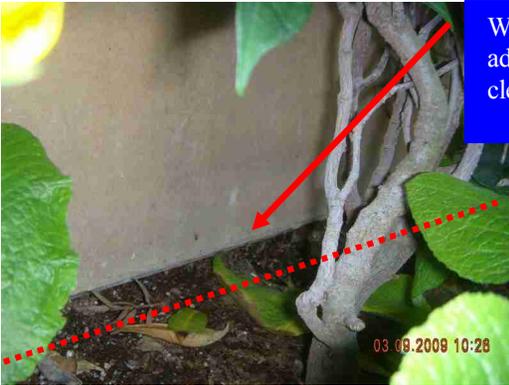
15. **Improve:** Insufficient soil/hardscape clearance from the "Weep" screed (a horizontal metal lip at the base of the stucco wall finish) noted. "Weep" screeds should be provided 2 inches clearance from hardscape and 6 inches from soil; suggest improving where needed (entry patio planter). Weep screeds allow water that soaks through the stucco to drain down the underlayment and exit the wall just above the foundation. Improper clearance can contribute to the corrosion of the metal screed, deterioration of the underlayment, provide a conveyance for insects and allow percolating water at the foundation to enter the structure and compromise the wood.

- **Improve:** A number of screens are damaged/missing; suggest repair as needed.
- **Improve:** Insufficient soil/hardscape clearance from the "Weep" screed (a horizontal metal lip at the base of the stucco wall finish) noted. "Weep" screeds should be provided 2 inches clearance from hardscape and 6 inches from soil; suggest improving where needed (entry patio planter). Weep screeds allow water that soaks through the stucco to drain down the underlayment and exit the wall just above the foundation. Improper clearance can contribute to the corrosion of the metal screed, deterioration of the underlayment, provide a conveyance for insects and allow percolating water at the foundation to enter the structure and compromise the wood.

Weep screed needs additional soil clearance

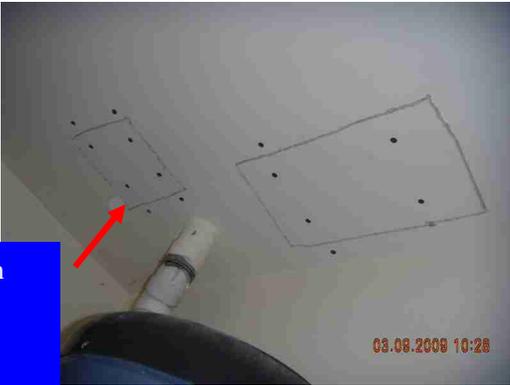
- **Safety Issue:** Proper fire separation between the garage and house proper is recommended. Cut-through fire-rated ceiling finishes noted above the central vacuum should be filled.

Patch ceiling cuts in garage

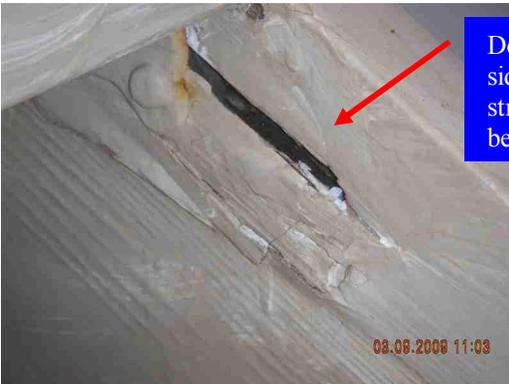
16. **Improve:** Wood deterioration noted at the S side-yard wood stairway stringers; suggest further review by a licensed contractor prior to the close of escrow or contingency period.

- **Improve:** Wood deterioration noted at the S side-yard wood stairway stringers; suggest further review by a licensed contractor prior to the close of escrow or contingency period.

Deterioration of the S side-yard stairway stringer (close-up below tread)

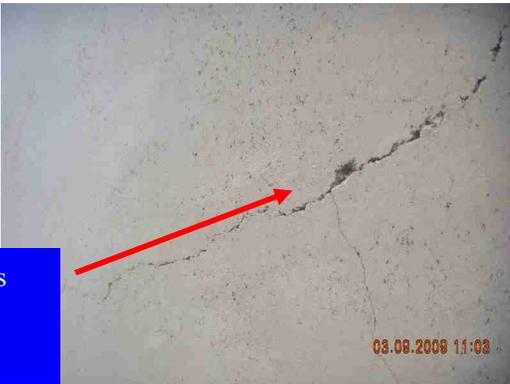
- **Improve:** The garage exterior service door rubs the jam; suggest improving.
- **Monitor:** A number of cracks were noted at various sections of the exterior stucco wall finish. This can be the result of insufficient curing of the undercoats, improper overlap of the paper-backed wire lathe, settling of the building, transitions between stucco application phases or "burning" of the top coat (excessively worked to a smooth finish), etc.; suggest further review by a licensed stucco contractor.

Stucco finish cracks

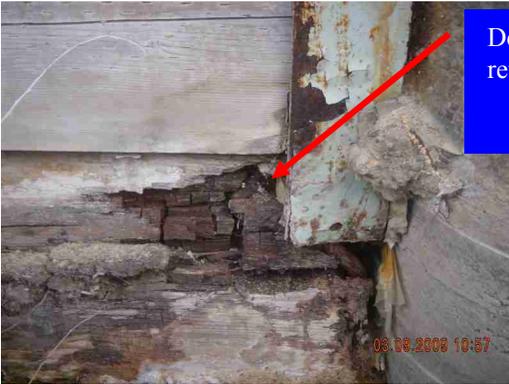
20. **Monitor:** The home site is provided exposed caissons at the W end atop the slope. Between each caisson, heavy wood timbers retain the soil. Some of the lower timbers show deterioration. Further, the steel brackets/saddles used to the secure the deck show deterioration as well. The wall and hillside should be evaluated by a geo-technical engineer prior to the close of escrow or contingency period.

- **Monitor:** The home site is provided exposed caissons at the W end atop the slope. Between each caisson, heavy wood timbers retain the soil. Some of the lower timbers show deterioration. Further, the steel brackets/saddles used to secure the deck show deterioration as well. The wall and hillside should be evaluated by a geotechnical engineer prior to the close of escrow or contingency period.

Deterioration of retaining wall timbers

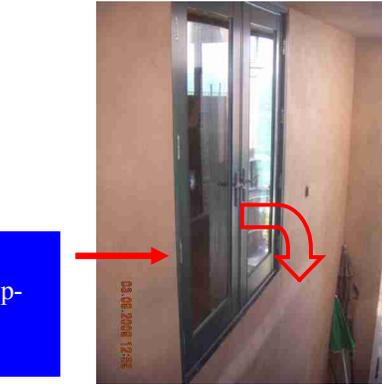
Living room deck doors open to a drop-off

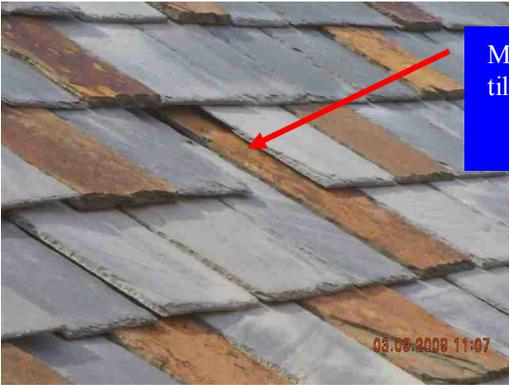
7. **Major Improve:** Repairs to the slate roofing are recommended through out as a number of loose, missing and damaged tiles and subsequent nail exposure was observed. Damaged or missing roofing material should be repaired. All roof penetrations should be examined and sealed as necessary; suggest further review by a licensed roofing contractor prior to the close of escrow or contingency period.

- **Major Improve:** Repairs to the slate roofing are recommended throughout as a number of loose, missing and damaged tiles and subsequent nail exposure was observed. Damaged or missing roofing material should be repaired. All roof penetrations should be examined and sealed as necessary; suggest further review by a licensed roofing contractor prior to the close of escrow or contingency period.

Missing slate roof tiles/exposed nails

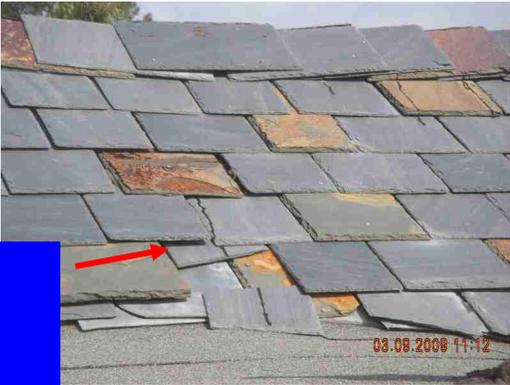
Missing/damaged slate roof tiles & exposed nails

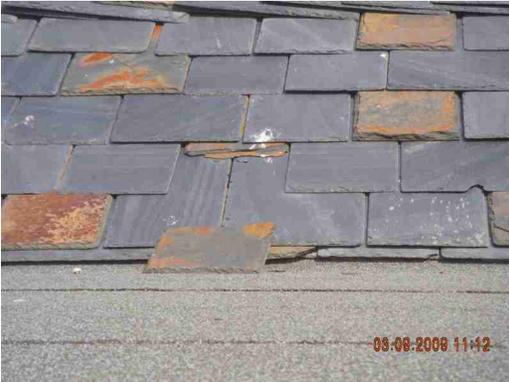
Missing slate roof tiles/exposed nails

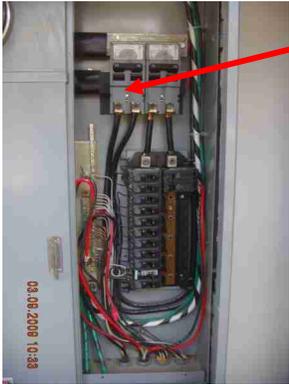
- **Monitor:** Indeterminate function of the detached ground conductor noted within the main electrical closet; suggest further review by a licensed electrical contractor prior to the close of escrow or contingency period.

Detached ground conductor

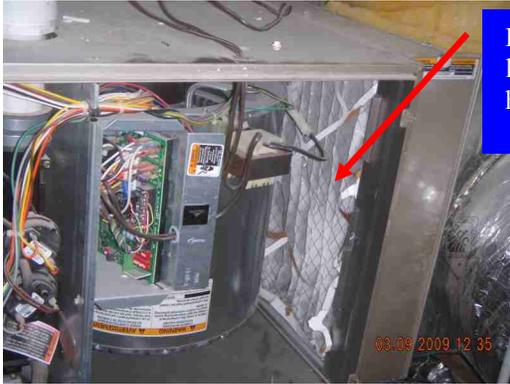
13. **Improve:** The dirty air filters serving the HVAC units should be replaced. The lower heating unit filter is damaged and difficult to remove.
14. **Improve:** Storage noted atop both of the heating unit's ducting should be removed to prevent damaged to the system,

- **Improve:** The dirty air filters serving the HVAC units should be replaced. The lower heating unit filter is damaged and difficult to remove.
- **Improve:** Storage noted atop both of the heating unit's ducting should be removed to prevent damaged to the system,

Damaged filter at lower forced air heating unit

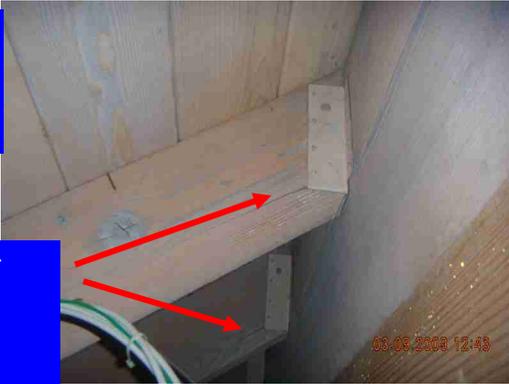
- **Monitor/Improve:** A majority of visible roof rafters were noted to be notched at the ridge board/beam connection to allow the use of floor joist metal hangers as fastening hardware. Floor joist anchors should not be used in this application as the rafter notch effectively acts as a split and can lead to additional rafter damage; suggest further inquiry with the builder prior to the close of escrow or contingency period. Split rafters were noted.

Splits noted at roof joists

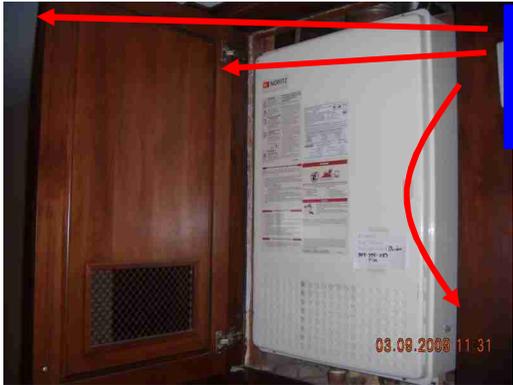
2. **Safety Issue:** The tankless water heater does not have safe clearance from combustible materials as specified on the manufacture's installation label. The unit sits within a wall stub framing bay and is within 3-6 inches from wood at the top, sides and front. This condition should be improved for safety reasons as tankless water heaters can radiate excessive heat; suggest further review by a licensed plumbing contractor prior to the close of escrow or contingency period.

- **Safety Issue:** The tankless water heater does not have safe clearance from combustible materials as specified on the manufacture’s installation label. The unit sits within a wall stub framing bay and is within 3 -6 inches from wood at the top, sides and front. This condition should be improved for safety reasons as tankless water heaters can radiate excessive heat; suggest further review by a licensed plumbing contractor prior to the close of escrow or contingency period.

Tankless water heater in alcove without sufficient clearance from combustibles
