# Building Inspection Report

## Monogram, Long Beach, CA

**Inspection Date:**  
4/10/09

**Prepared By:**  
Beachside Property Inspection, LLC  
5318 E. 2<sup>nd</sup> St., #707  
Long Beach, CA, 90803  
ph. (562) 433-2288  
fax: (562) 987-2424

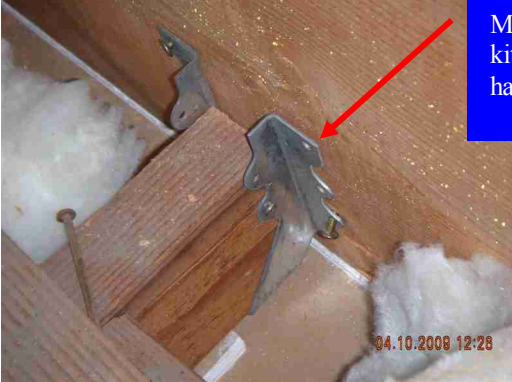
- **Improve/Safety Issue:** Improper fastening of the kitchen ceiling joist hangers noted. Various hangers are loose and are missing nails at connections; suggest further review by a licensed contractor prior to the close of escrow or contingency period.

Missing nails at kitchen ceiling joist hangers

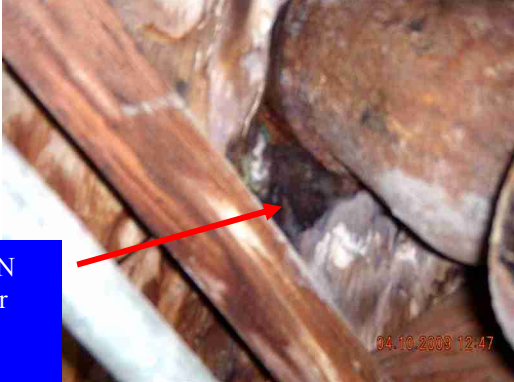
- **Improve:** All wood debris and/or trash should be removed from the living room crawl space.
- **Improve:** Damp framing noted at the lower N bathroom toilet sub-floor; suggest installation of a new wax ring and further review by a licensed structural pest control operator prior to the close of escrow or contingency period.

Dark damp area at N bath toilet sub-floor

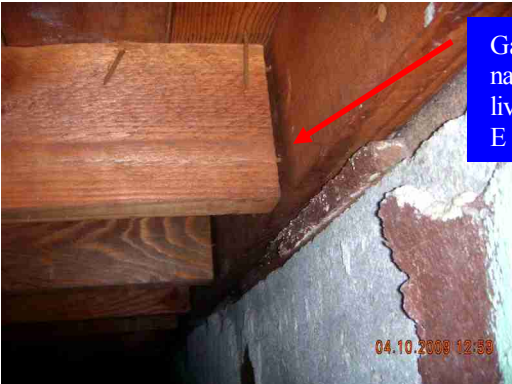
Gaps with exposed nails noted at the living room floor joist E end connections

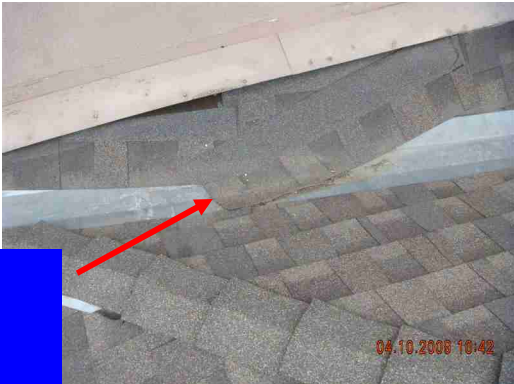
- **Improve:** Rooftop ABS plumbing vent pipes should be painted for improved UV protection.
- **Improve:** Repairs to the sloped roofing are recommended (the valley area E of the master bathroom). The loose roofing material should be repaired. All roof penetrations should be examined and sealed as necessary; suggest further review by a licensed roofing contractor prior to the close of escrow or contingency period.

Loose shingles at valley

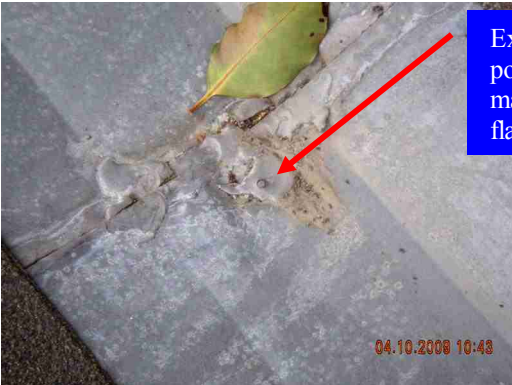
Exposed nail is popping through mastic at valley flashing

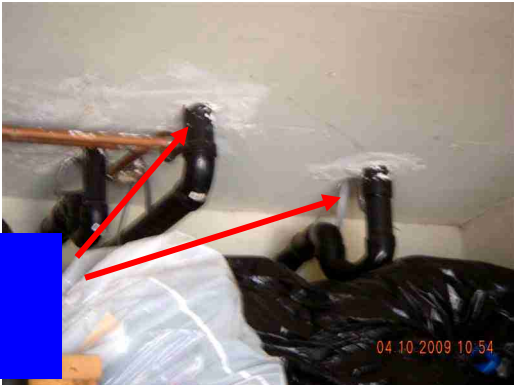
- **Safety Issue:** Proper fire separation between the garage and house proper is recommended. Missing fire -rated wall finishes noted at various locations below the upper hall bath (NE ceiling of garage) must be patched with “X -type”, 5/8ths of an inch, fire rated sheetrock. Further, any gaps should be filled and pipe penetrations sealed tight around their perimeter where they pass through the wall; suggest further review by a licensed contractor prior to the close of escrow or contingency period.

Plastic waste pipes passing through garage fire-rated ceiling finish

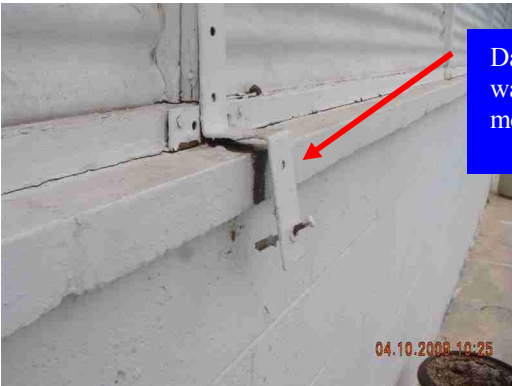
- **Improve:** Leaning sections noted at the S fencing. The N gates are loose; suggest improving.
- **Improve:** The block wall’s wooden privacy extension mounts are dilapidated/damaged; suggest removal/rebuild.

Damaged property wall privacy fence mount

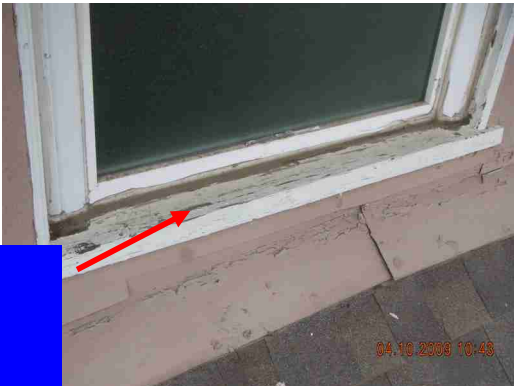
- **Improve:** The home's exterior wood elements/features shows paint and some wood deterioration that will require (in various degrees) replacement, repair, and paint. Suggest a review of the pest report for the condition of this and all wood. Areas of concern include: upper level W siding/trim, rook gable boards, etc.)

Paint deterioration

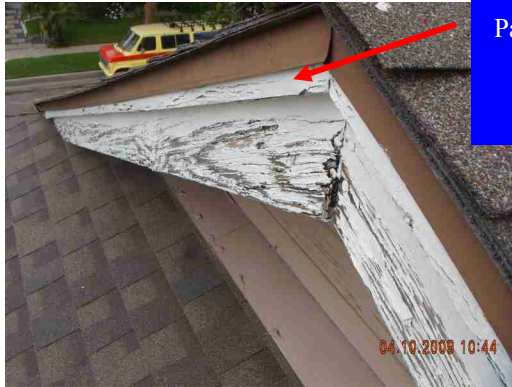
Paint deterioration

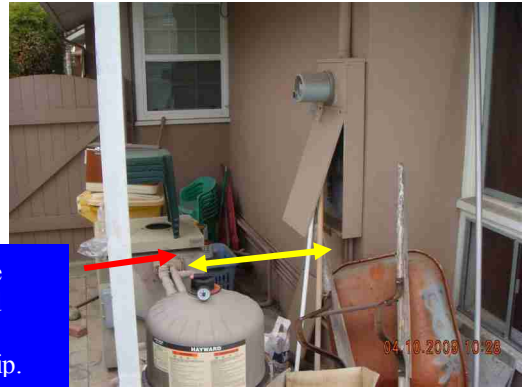
- **Major Improve:** Insufficient service clearance noted at the main and adjacent branch electrical panels. The pool equipment is within the 3 -feet of frontal clearance area required; suggest further review by a licensed pool contractor prior to the close of escrow or contingency period. The pool equipment should be re-located.

Insufficient service clearance provided between electrical panels & pool equip.

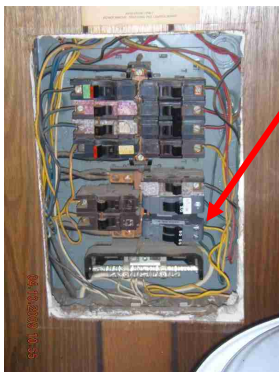
- **Safety Issue:** Oversized breakers within the garage electrical auxiliary panel should be replaced. The two 30amp breakers are serving household branch circuits wired with 12 -gauge conductors rated for 20-amps; suggest further review by a licensed electrical contractor prior to the close of escrow or contingency period.

Garage panel has 30 - amp breakers attached to 12-gauge conductors

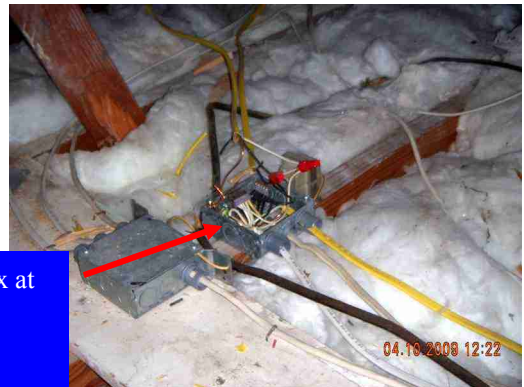
- **Safety Issue:** Multiple open electrical junction boxes noted at the lower level attic. All visible wiring connections should be enclosed within ***covered junction boxes***; suggest conforming installation. A common reason for missing junction box covers is an overfilled box. If this is the case, an extension ring can be added to provide extra cover clearance; suggest further review by a licensed electrical contractor prior to the close of escrow or contingency period.

Open electrical box at attic

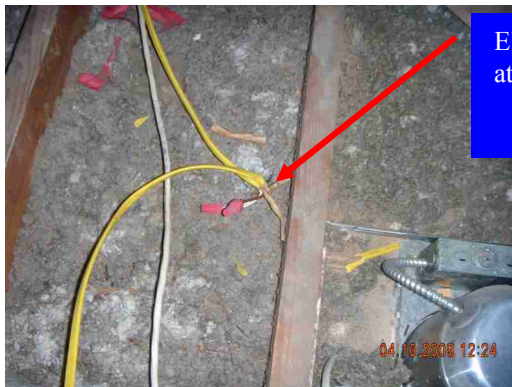
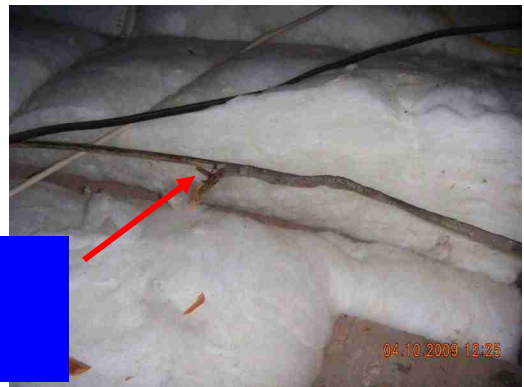
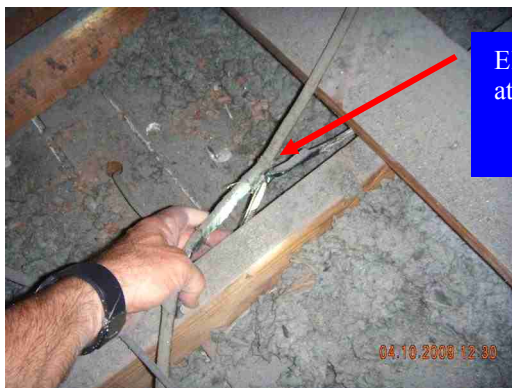
- **Safety Issue:** Multiple running electrical splices noted at the lower level attic space (kitchen and S bath areas); all electrical connections should be made within covered junction boxes; suggest conforming installation.

Electrical splice at attic

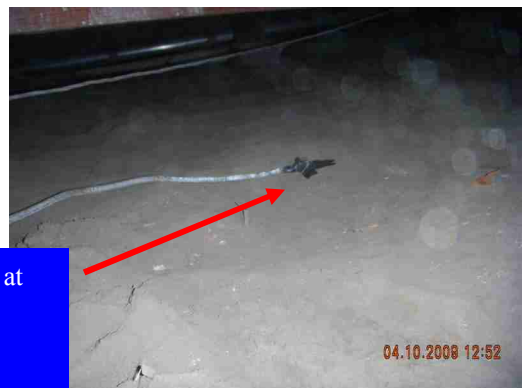
- **Improve/Safety Issue:** Improper termination of disconnected electrical conductors noted at the family room SE corner, N hallway and kitchen crawl spaces. All terminated/abandoned conductors should be enclosed within covered junction boxes or the conductors removed altogether; suggest conforming installation.

Abandoned wiring at crawl space

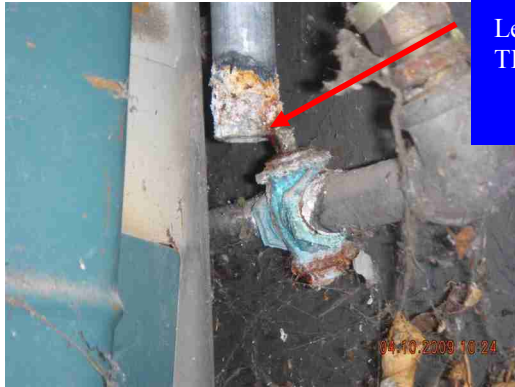
31. **Improve:** The Temperature and Pressure Relief (TPR) Valve serving the water heater is leaking; suggest further review by a licensed plumbing contractor prior to the close of escrow or contingency period.

Leak at water heater TPR discharge pipe

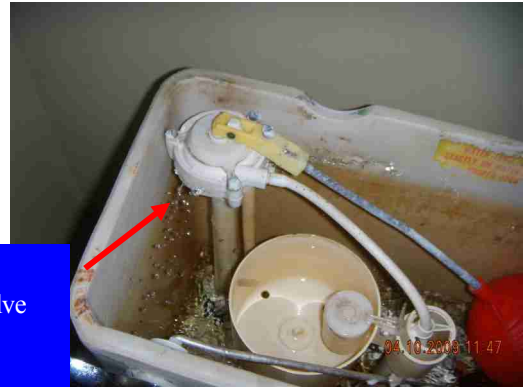
25. **Improve:** Leak noted at the upper hall toilet tank filler float valve; suggest further review by a licensed plumbing contractor prior to the close of escrow or contingency period.

Leak at upper hall toilet tank filler valve

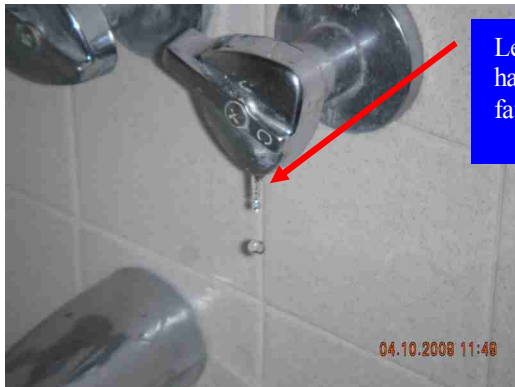
- **Improve:** Leak noted at the upper hall shower/tub cold water faucet; suggest improving.

Leak at upper level hall shower cold water faucet

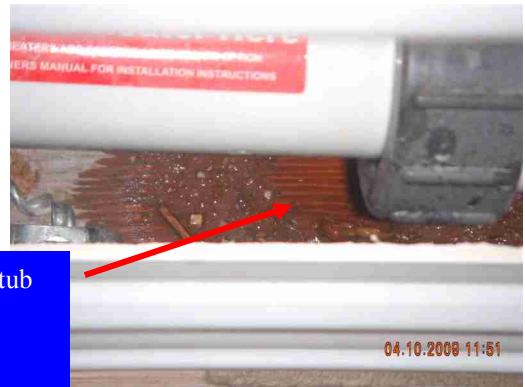
24. **Improve:** Leak noted at the whirlpool tub jet plumbing; suggest further review by a licensed plumbing contractor prior to the close of escrow or contingency period.

Leak at whirlpool tub jet plumbing

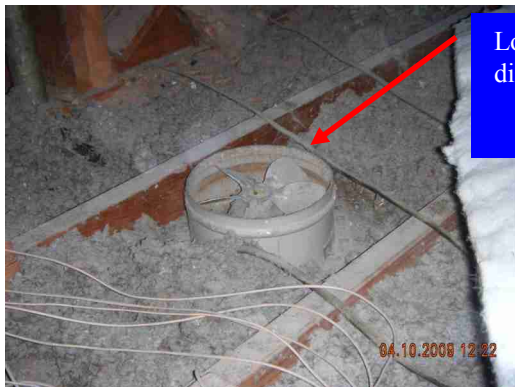
23. **Improve/Safety Issue:** Both of the lower level bathroom ceiling exhaust fans vent directly in to the attic space (allowing moisture into a confined area and compromising the fire -rating of the living space). The fan should be provided with a flexible/rigid metal duct terminating at an exterior vent; suggest improvements.

Lower bathroom fans discharge to the attic

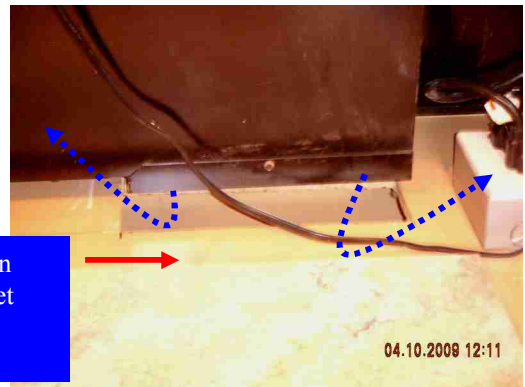
Kitchen exhaust fan discharge to cabinet
