# Building Inspection Report

**Long Beach, CA**

**Prepared By:**  
Beachside Property Inspection, LLC  
5318 E. 2<sup>nd</sup> St., #707  
Long Beach, CA, 90803  
ph. (562) 433-2288

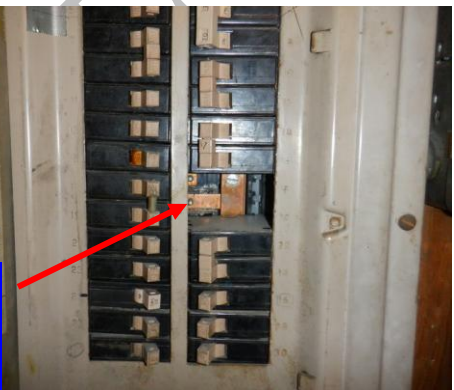
The NW-electrical service group's left enclosure also powers an added meter enclosure that requires operating 3 more breakers and where the original panel has an un-capped meter socket containing live parts
