# Commercial Building Inspection Report

## Major Components Only

Long Beach, CA

**Inspection Date:**  
December 2018

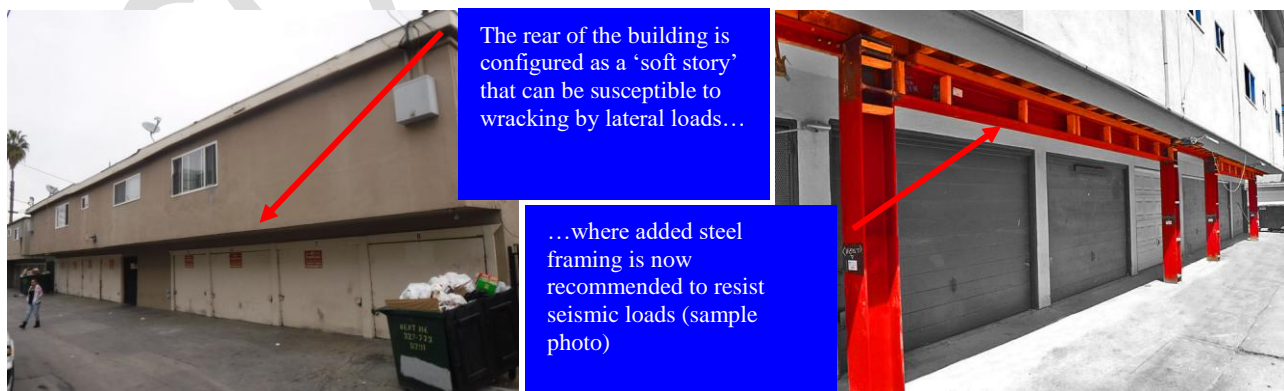
## Photos

1. **Major Improve:** The building's configuration at the alley area where the living space is above adjacent garages has documented issues regarding its poor performance in resisting lateral loads due to seismic activity. Referred to as 'Soft Story' structures prone to racking and/or collapse, the building should be assessed by a licensed structural engineer for the installation of steel framed vehicle door openings.
2. **Monitor:** The building's slab foundation exhibited no observed defects at its perimeter areas and the slab's top surface was obstructed by floor finishes. Client is advised that cracks may exist below flooring finishes, however, no significant off-sets were noted or detected. It is recommended that the seller be consulted regarding any knowledge of the slab's condition when it was exposed during installation of newer floor finishes.
