Building Inspection Report

La Senda, Laguna Beach, CA

Inspection Date:
3/9/09

Prepared By:
Beachside Property Inspection, LLC
5318 E. 2nd St., #707
Long Beach, CA, 90803
ph. (562) 433-2288
fax: (562) 987-2424

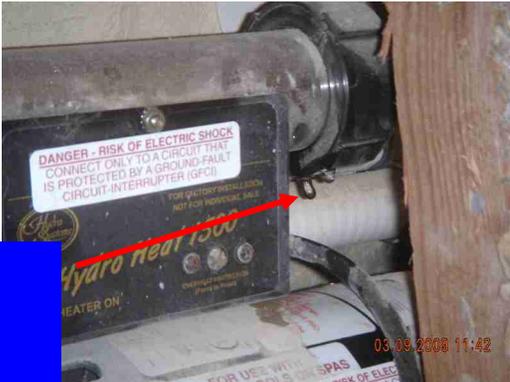
8. **Improve:** Leak noted at the whirlpool tub pump fitting; suggest further review by a licensed plumbing contractor prior to the close of escrow or contingency period.

Leak at whirlpool pump connection
