# Building Inspection Report

**Long Beach, CA**

**Prepared By:**  
Beachside Property Inspection, LLC  
5318 E. 2<sup>nd</sup> St., #707  
Long Beach, CA, 90803  
ph. (562) 433-2288

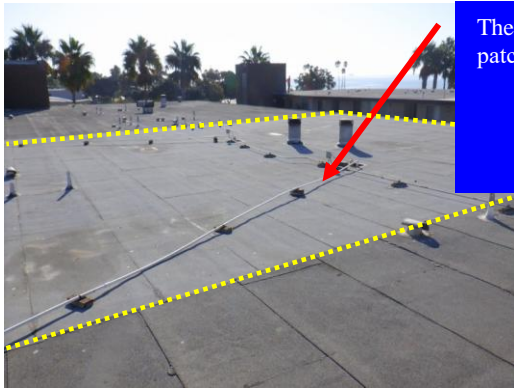
1. **Major Concern:** The roll roofing is older (disclosed to be 12 years old with a typical service life of 15+ years) that is nearing the end of its expected service life and exhibits some repairs: a large section over the center area of the N-wing (units 304/305?), at the NW drain area and at S-wing (315/316?). Further, ripples were noted at the 307-309 roofing. As well, 6 added surface pumps at the 307-309 roof area and at the W-half of the N-wing (located within small basins that may have been proper built-in drain scuppers that have become obstructed) indicate poor drainage where roof slope improvements may be needed, original drains cleared or the installation of a single-ply PVC roll roof membrane with sonic-welded seams that provides a water proof surface impervious to standing water. As well, of the 6 pumps, two did not respond to power re-sets (roughly at the 305 & 307 areas) and the 308 roof area pump drain pipe has detached. Finally, a few of the pump basins have separating surface material where water appears to seep below the cap sheet. As a whole, much of the roof at the S-wing is in good condition where as the balance of areas have issues (whether needing pumps, having large repairs, surface wear/cracks/blisters, etc.); suggest further assessment and repairs and/or section replacement by a licensed roofing contractor.

The roof has a number of patched areas...

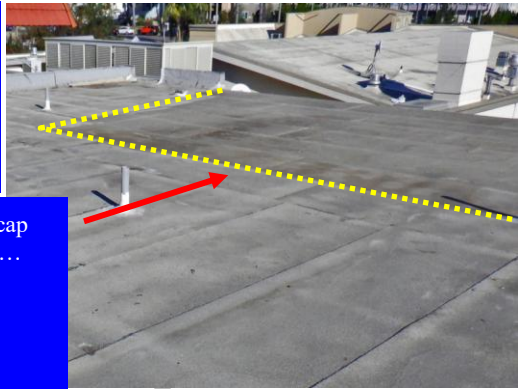
...consisting of added cap sheet or roll-on sealant...

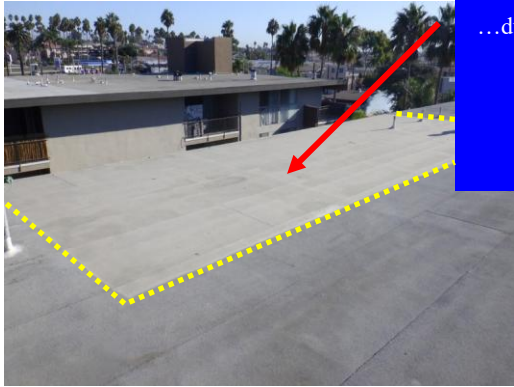
...due to its age...

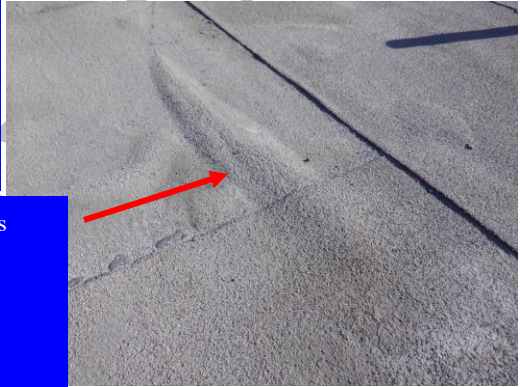
...where it also exhibits blisters

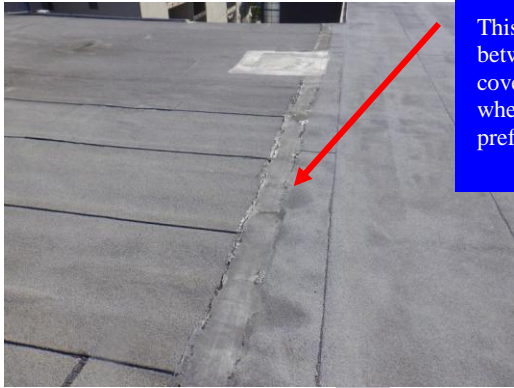
This roof transition between 309 & 310 is covered with thick sealant where a roll roofing strip is preferred

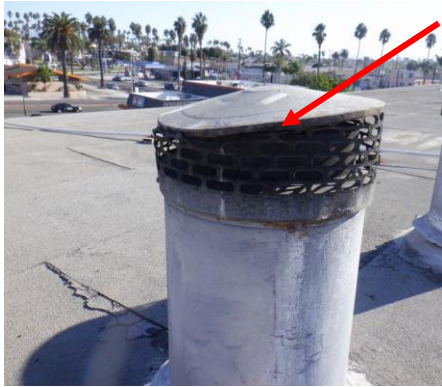
2. **Major Improve/Safety Issue:** The rooftop has a number of fireplace metal chimney pipes (12) of which 3 are no longer in use (3<sup>rd</sup> level dwelling unit numbers are used to identify their approximate locations) of which the 302 pipe is a disassembled pile set atop the roof opening it once passed through, the 308 pipe remains loosely set within the roof opening where it rests atop the ceiling finish and the 310 chimney has its cap replaced with a flat sheet metal sealing the top of the pipe. Additionally, of the remaining 9 chimneys, the ones at 307, 311 & 312 are fitted with gas appliance vent caps that are not listed for wood burning fireplace chimney caps (improper caps restrict the discharge of combustion products within the living space). The balance of chimney caps appear correct, however, the cap at 306A is collapsing; suggest immediate assessment and repairs by a licensed chimney contractor.

306A: The proper chimney cap is collapsing...

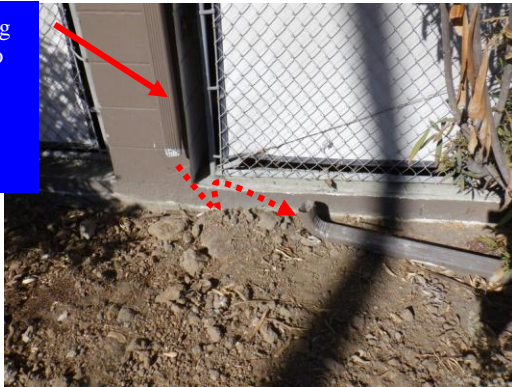
The gutters are discharging against the building due to detached lateral runs

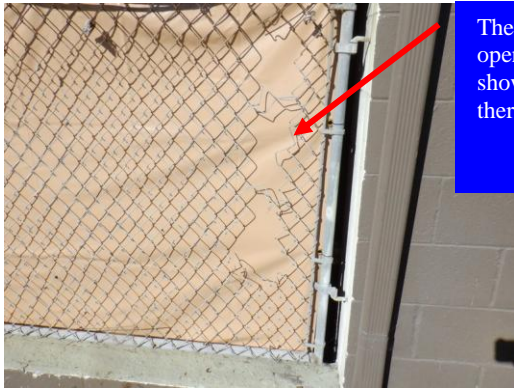
The garage N and S-wall opening fencing panels show damage here and there

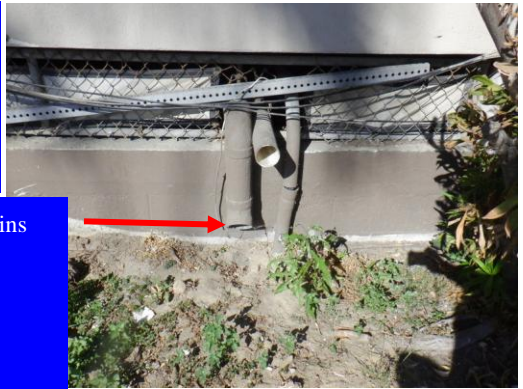
The terrace surface drains discharge against the building

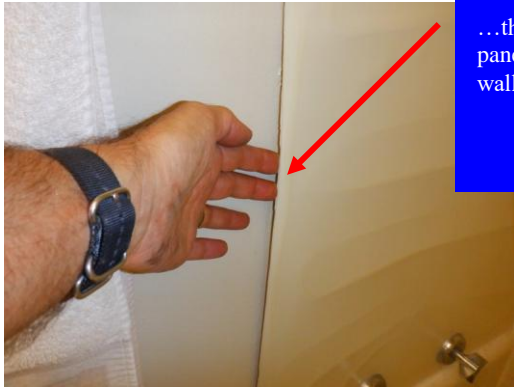
...the hall bath shower panel is detaching from the wall...

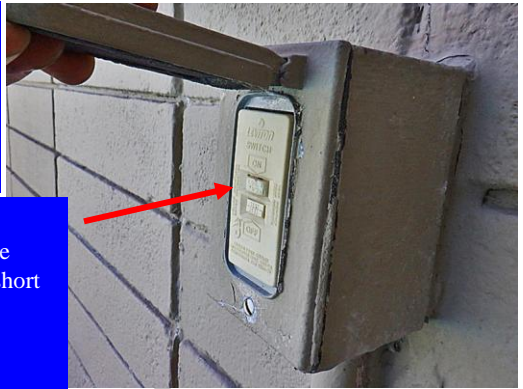
...and its tripped GFCI shock protection feature indicates an electrical short

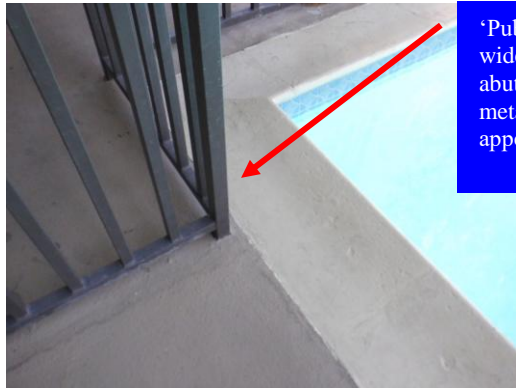
'Public' pools require a 4' wide unobstructed decking abutting the water and the metal fencing does not appear to be 'bonded'...

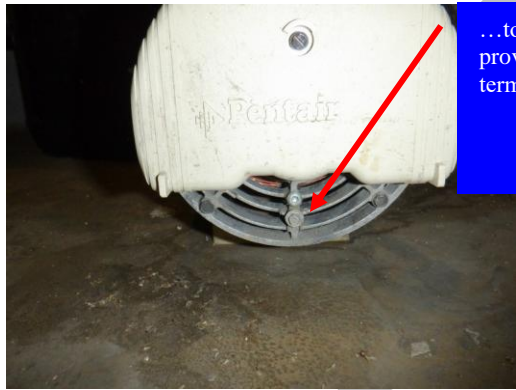
...to the pool pump's provided bonding terminal...
